Black Butte Coal Mine Exceptional Events Documentation for the Event on January 13, 2014 Pit 10 TEOM Location

Black Butte Coal Company

April 29, 2014

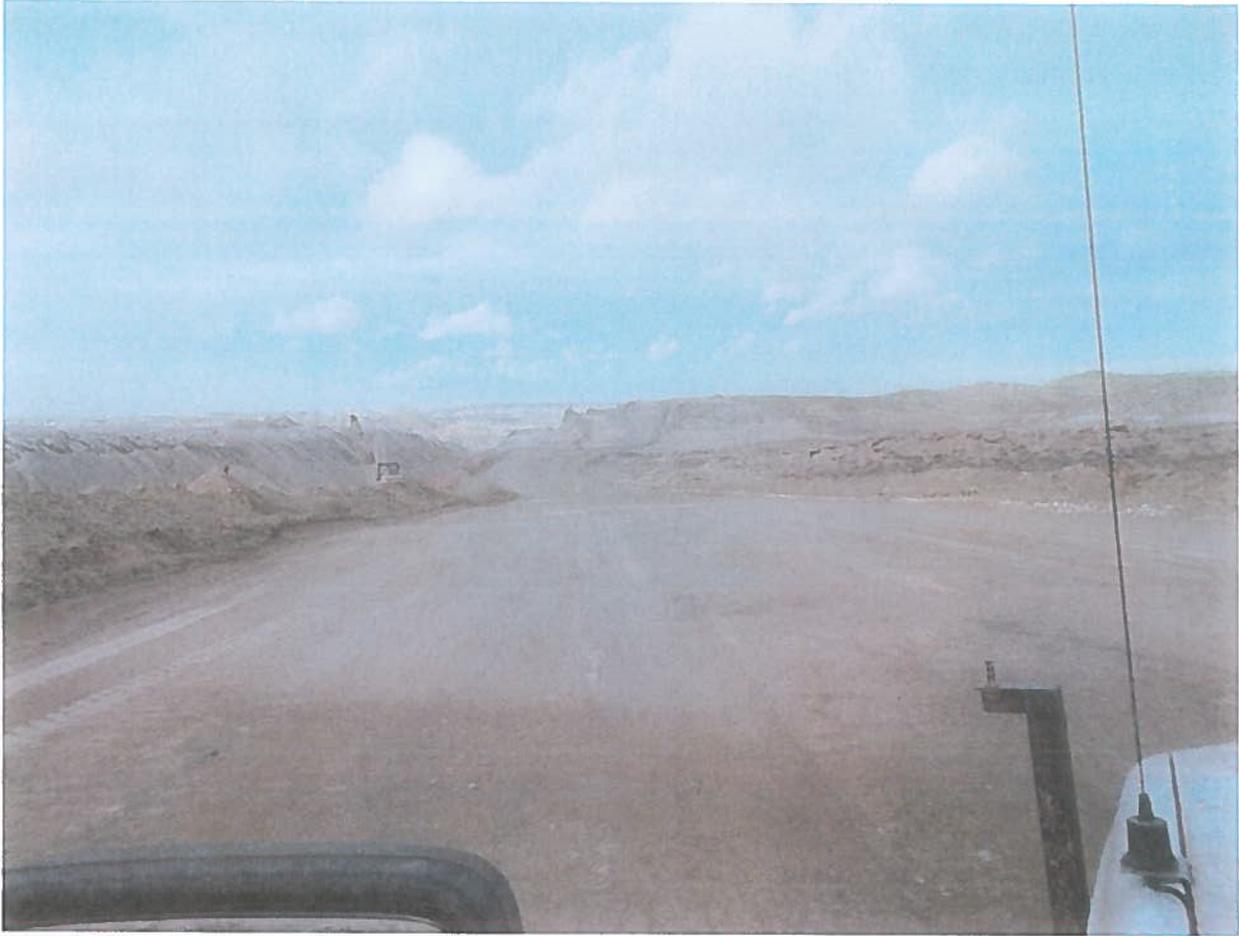
Figure II.1 Water Application on temp haulroad.

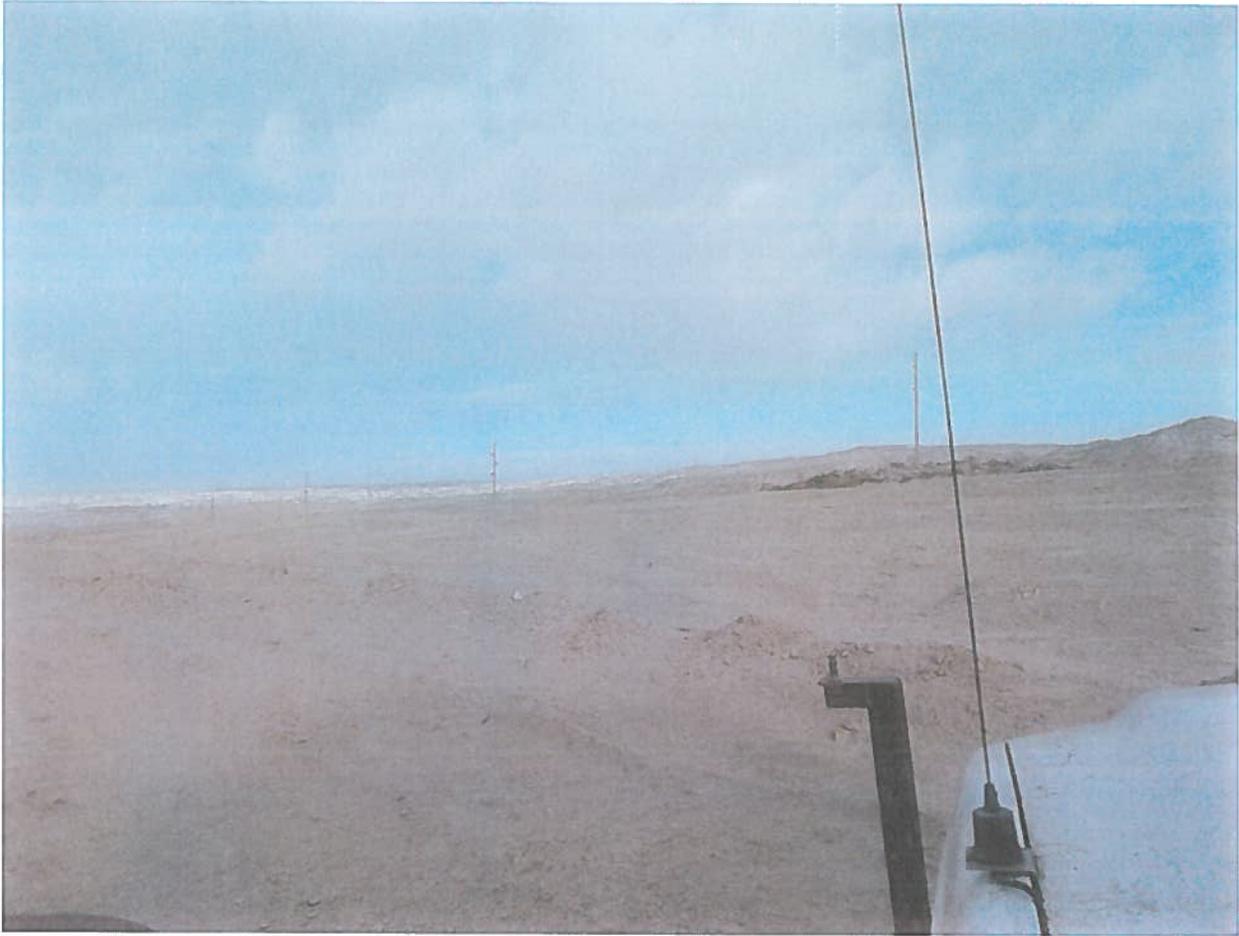
Figure II.2 Water application on topsoil prestrip.

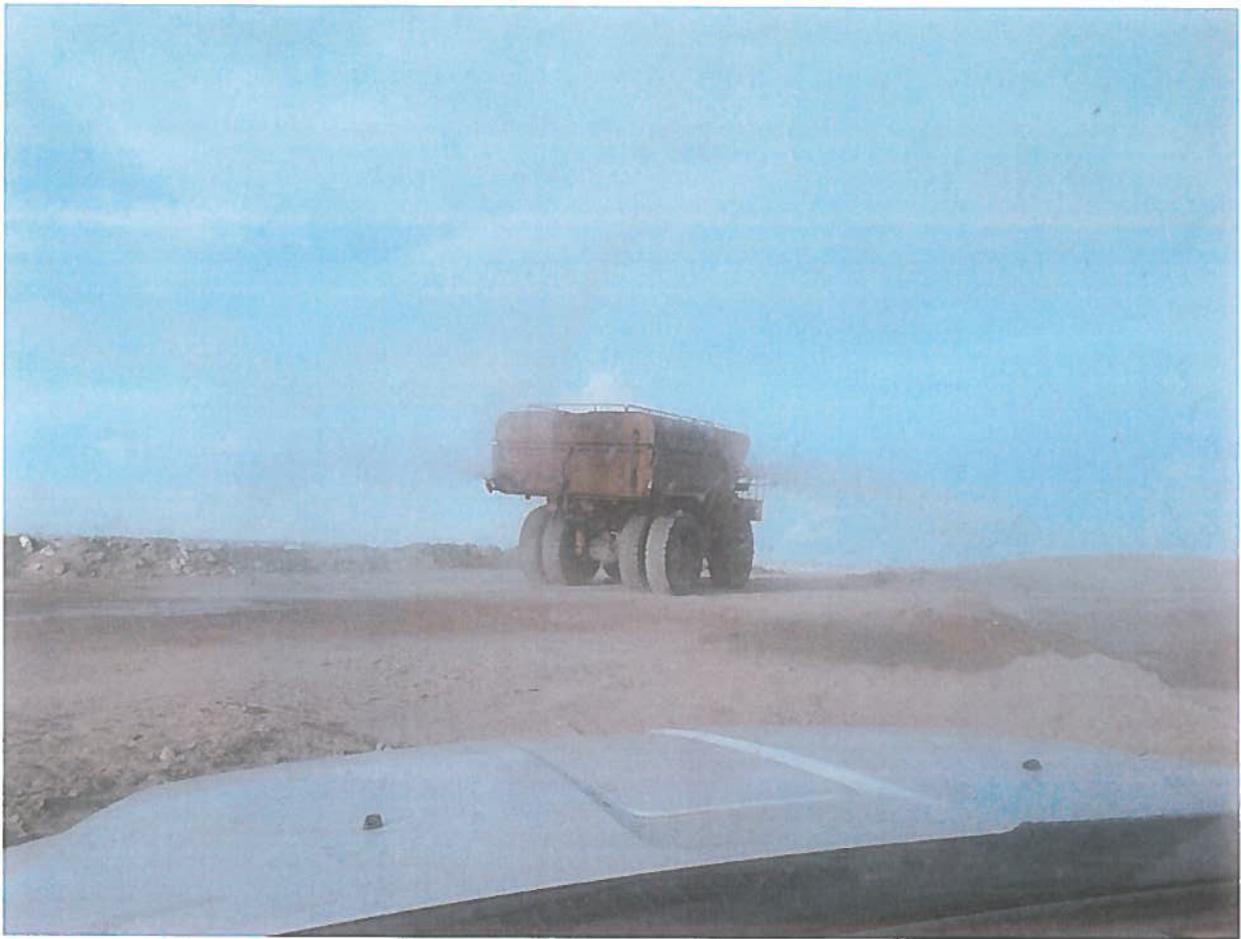
Figure II.3 Water application on Pit 10 highwall and berms.

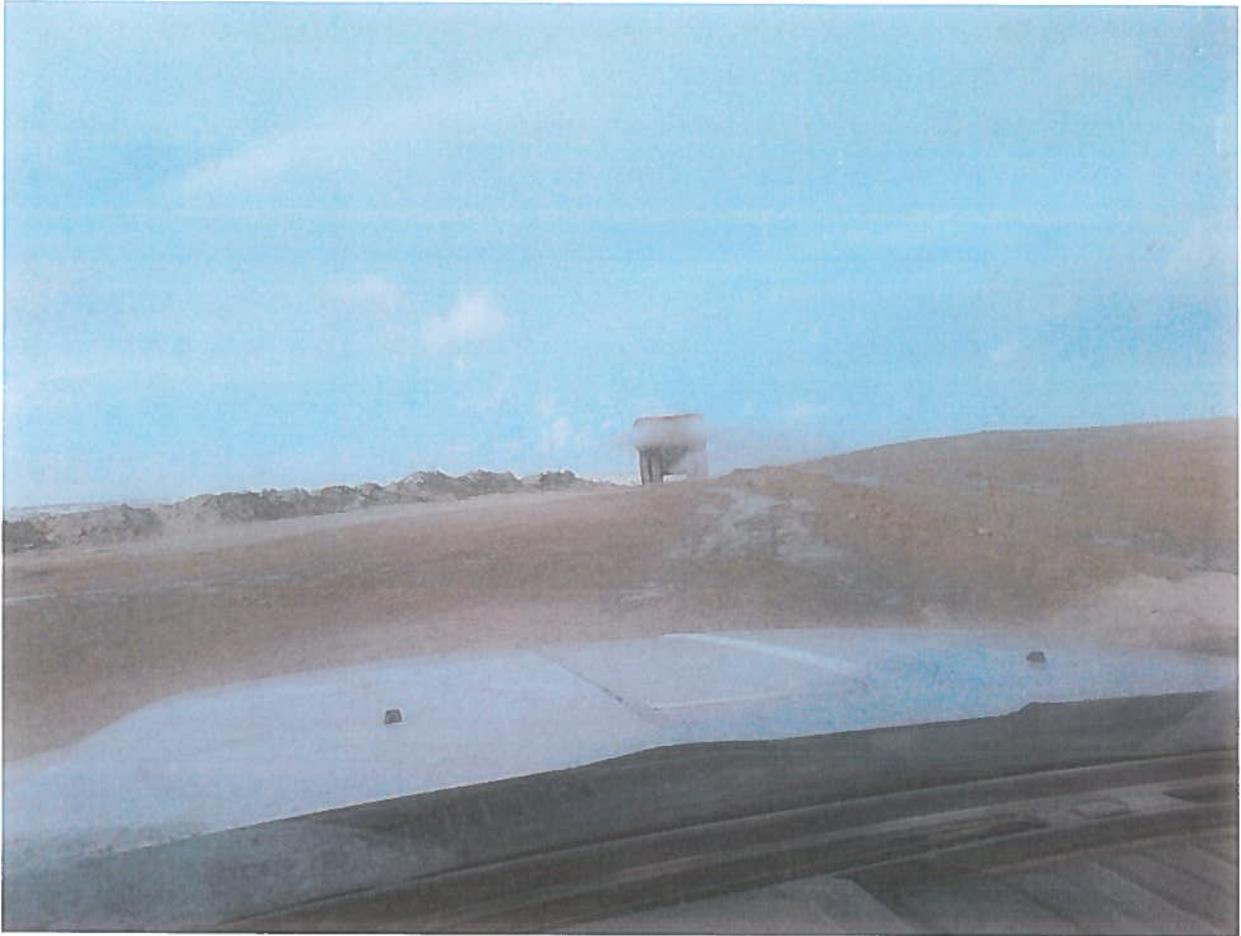
Figure II.4 Water application on Pit 10 highwall and prestrip.

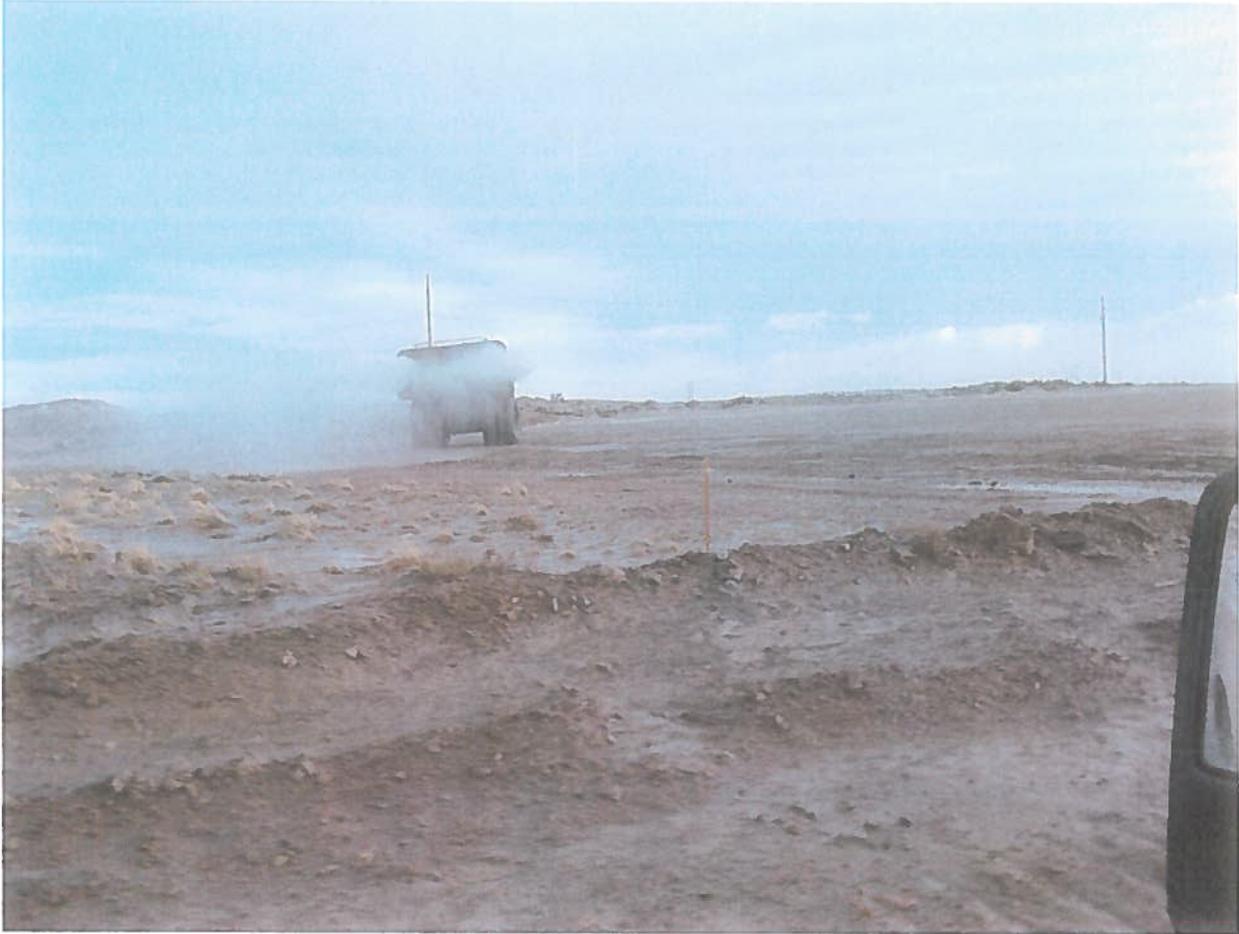
Figure II.5 Water application on prestrip and native.

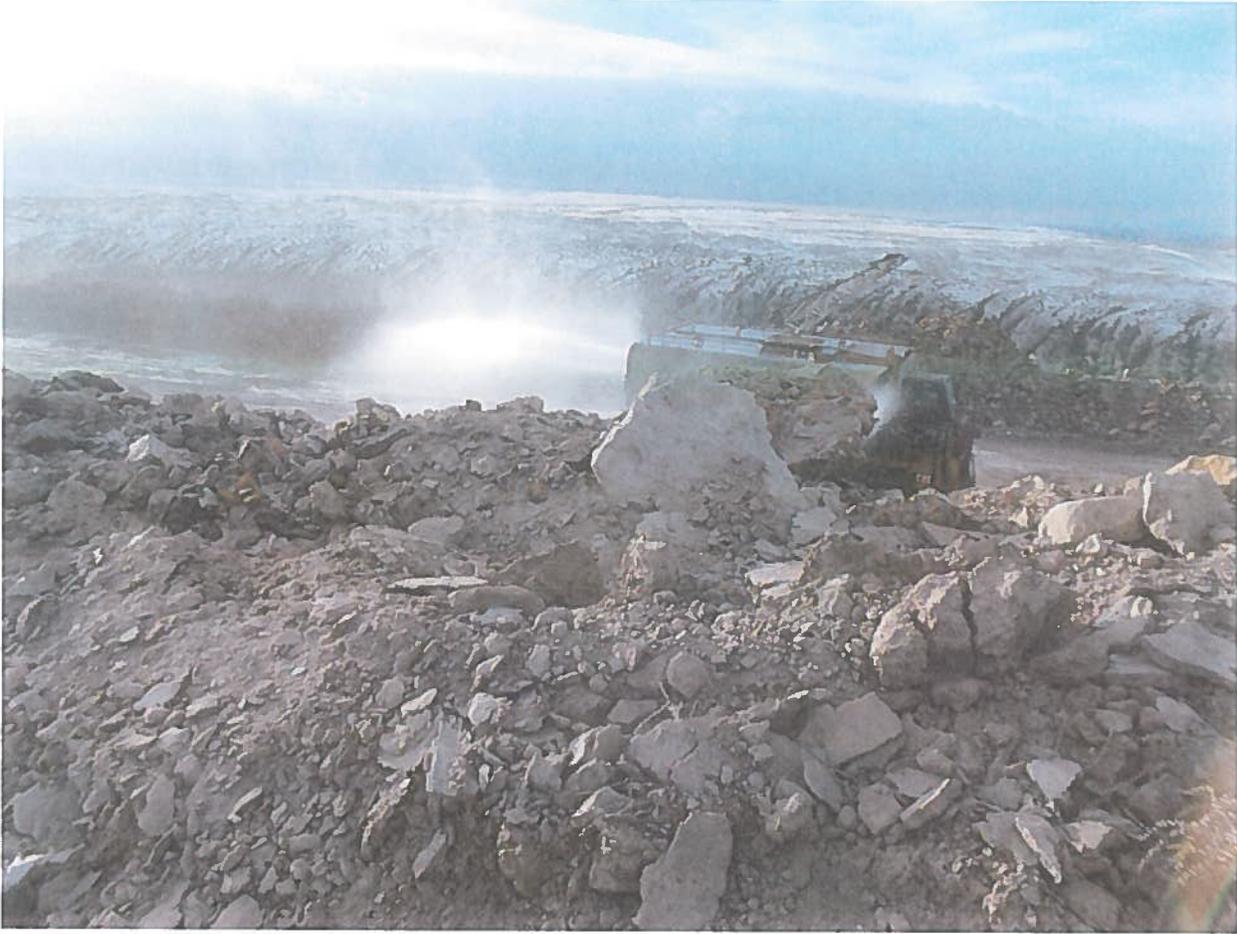
Figure II.6 Water application on highwall and berms.

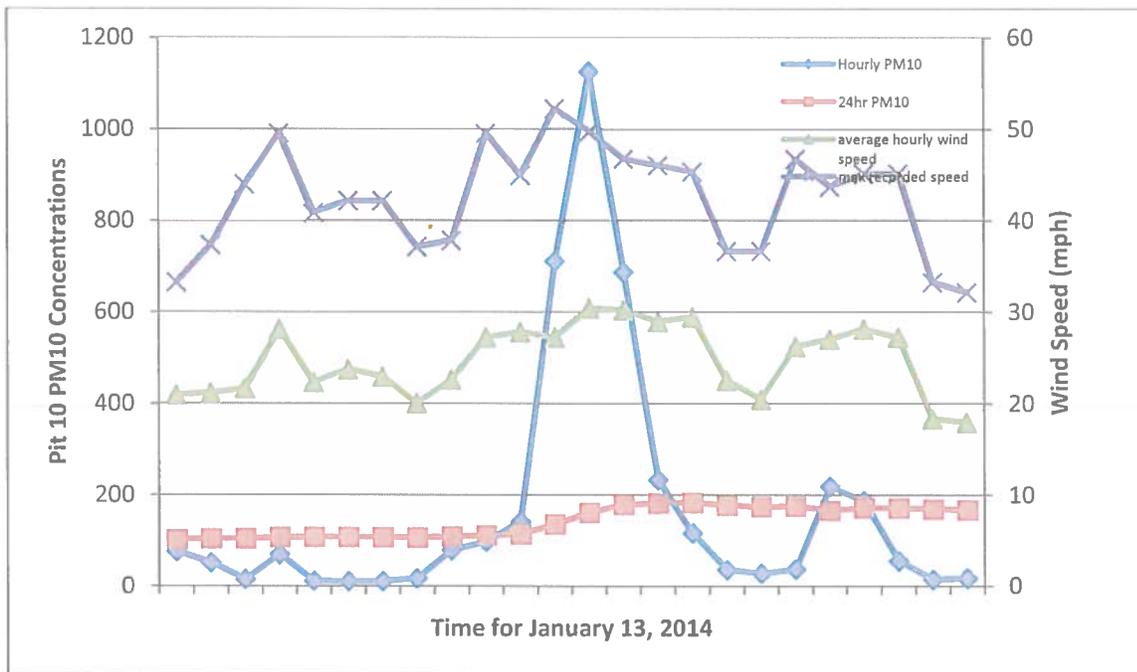
Figure III.1 shows the correlation of wind speed and PM10 concentrations recorded on January 13, 2014 for the Pit 10 TEOM. As has been seen in the past once sustained wind speeds go above the 30 mph mark the approved controls utilized by Black Butte Coal begin to have diminished effectiveness.

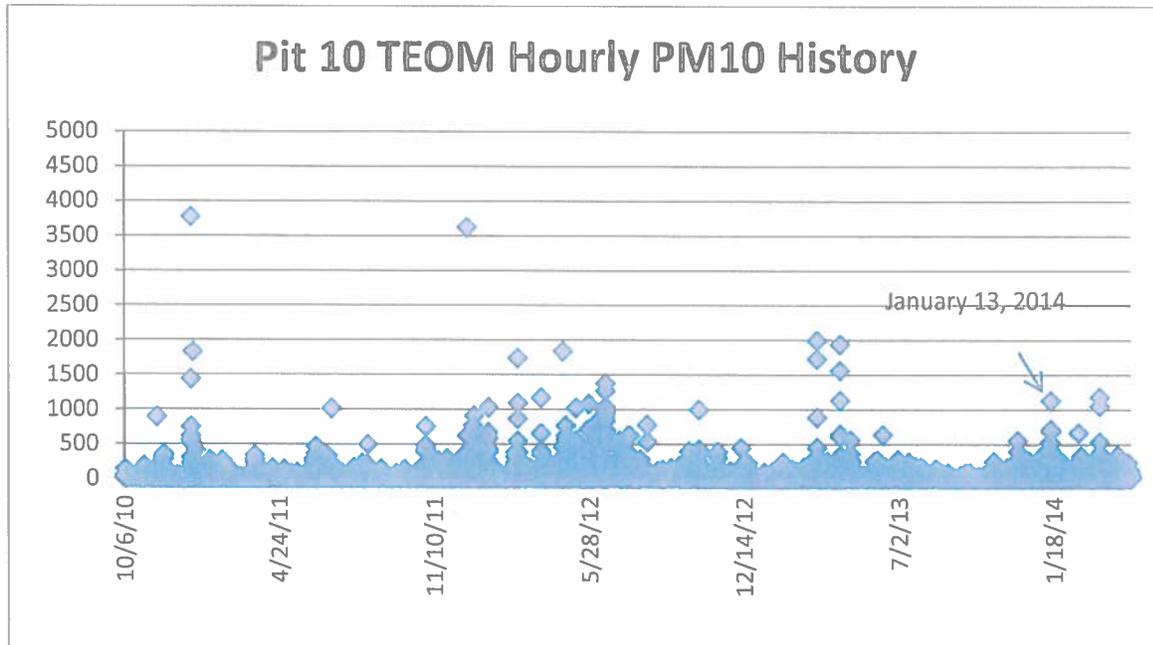
Figure V.1

The Environmental Protection Agency, EPA, generally considers a 3-5 year time period when looking at Normal Historical Fluctuations. Data for this document looked at a five year time period from May 5, 2009 through April 27, 2014. Time series plots of the hourly readings from October, 2010 through April, 2014 were created for the Pit 10 monitor. Additionally data was compiled for the time period of May 5, 2009 through April, 2014. A shorter time period was used in this graph to make the graphical depiction clearer.

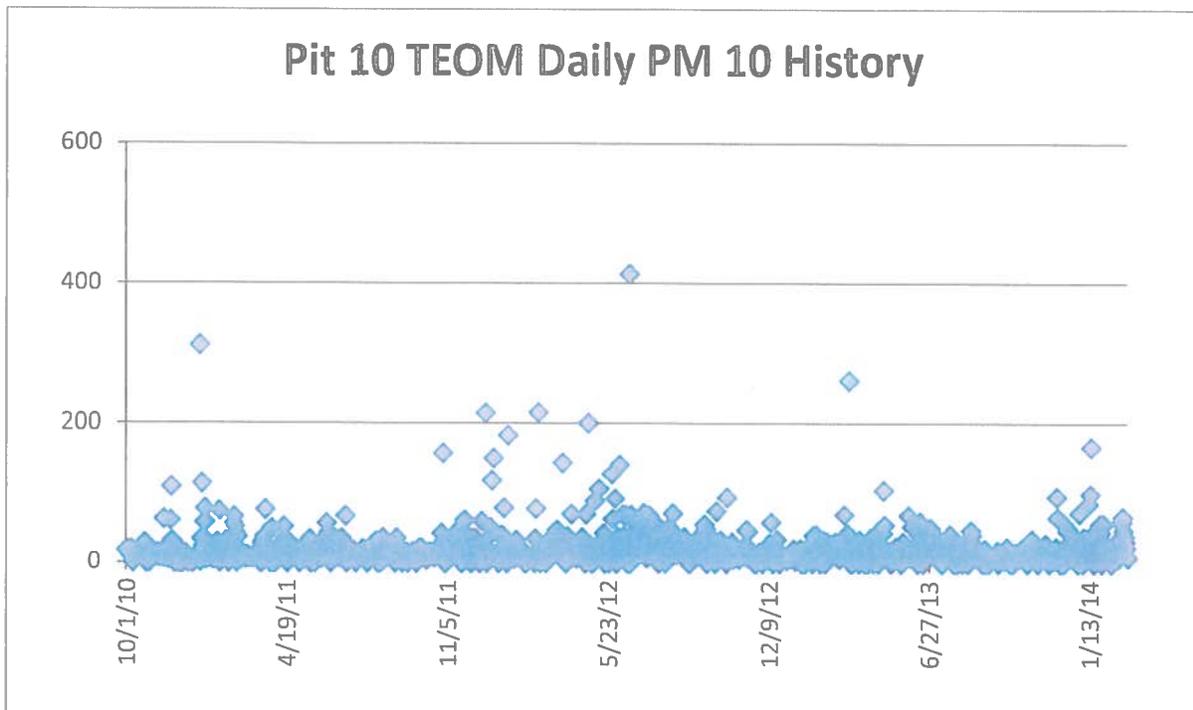
Figure V.2

Time series graphs were also produced for the PM10 daily averages over a five year span from May 5, 2009 through February 28, 2014. Out of a total of 1,776 valid data points only 5 readings were above the $166 \mu\text{g}/\text{m}^3$ mark. This places the January 13, 2014 daily reading of $166.3 \mu\text{g}/\text{m}^3$ in the 99.9 percentile of all daily readings in the last 5 years.

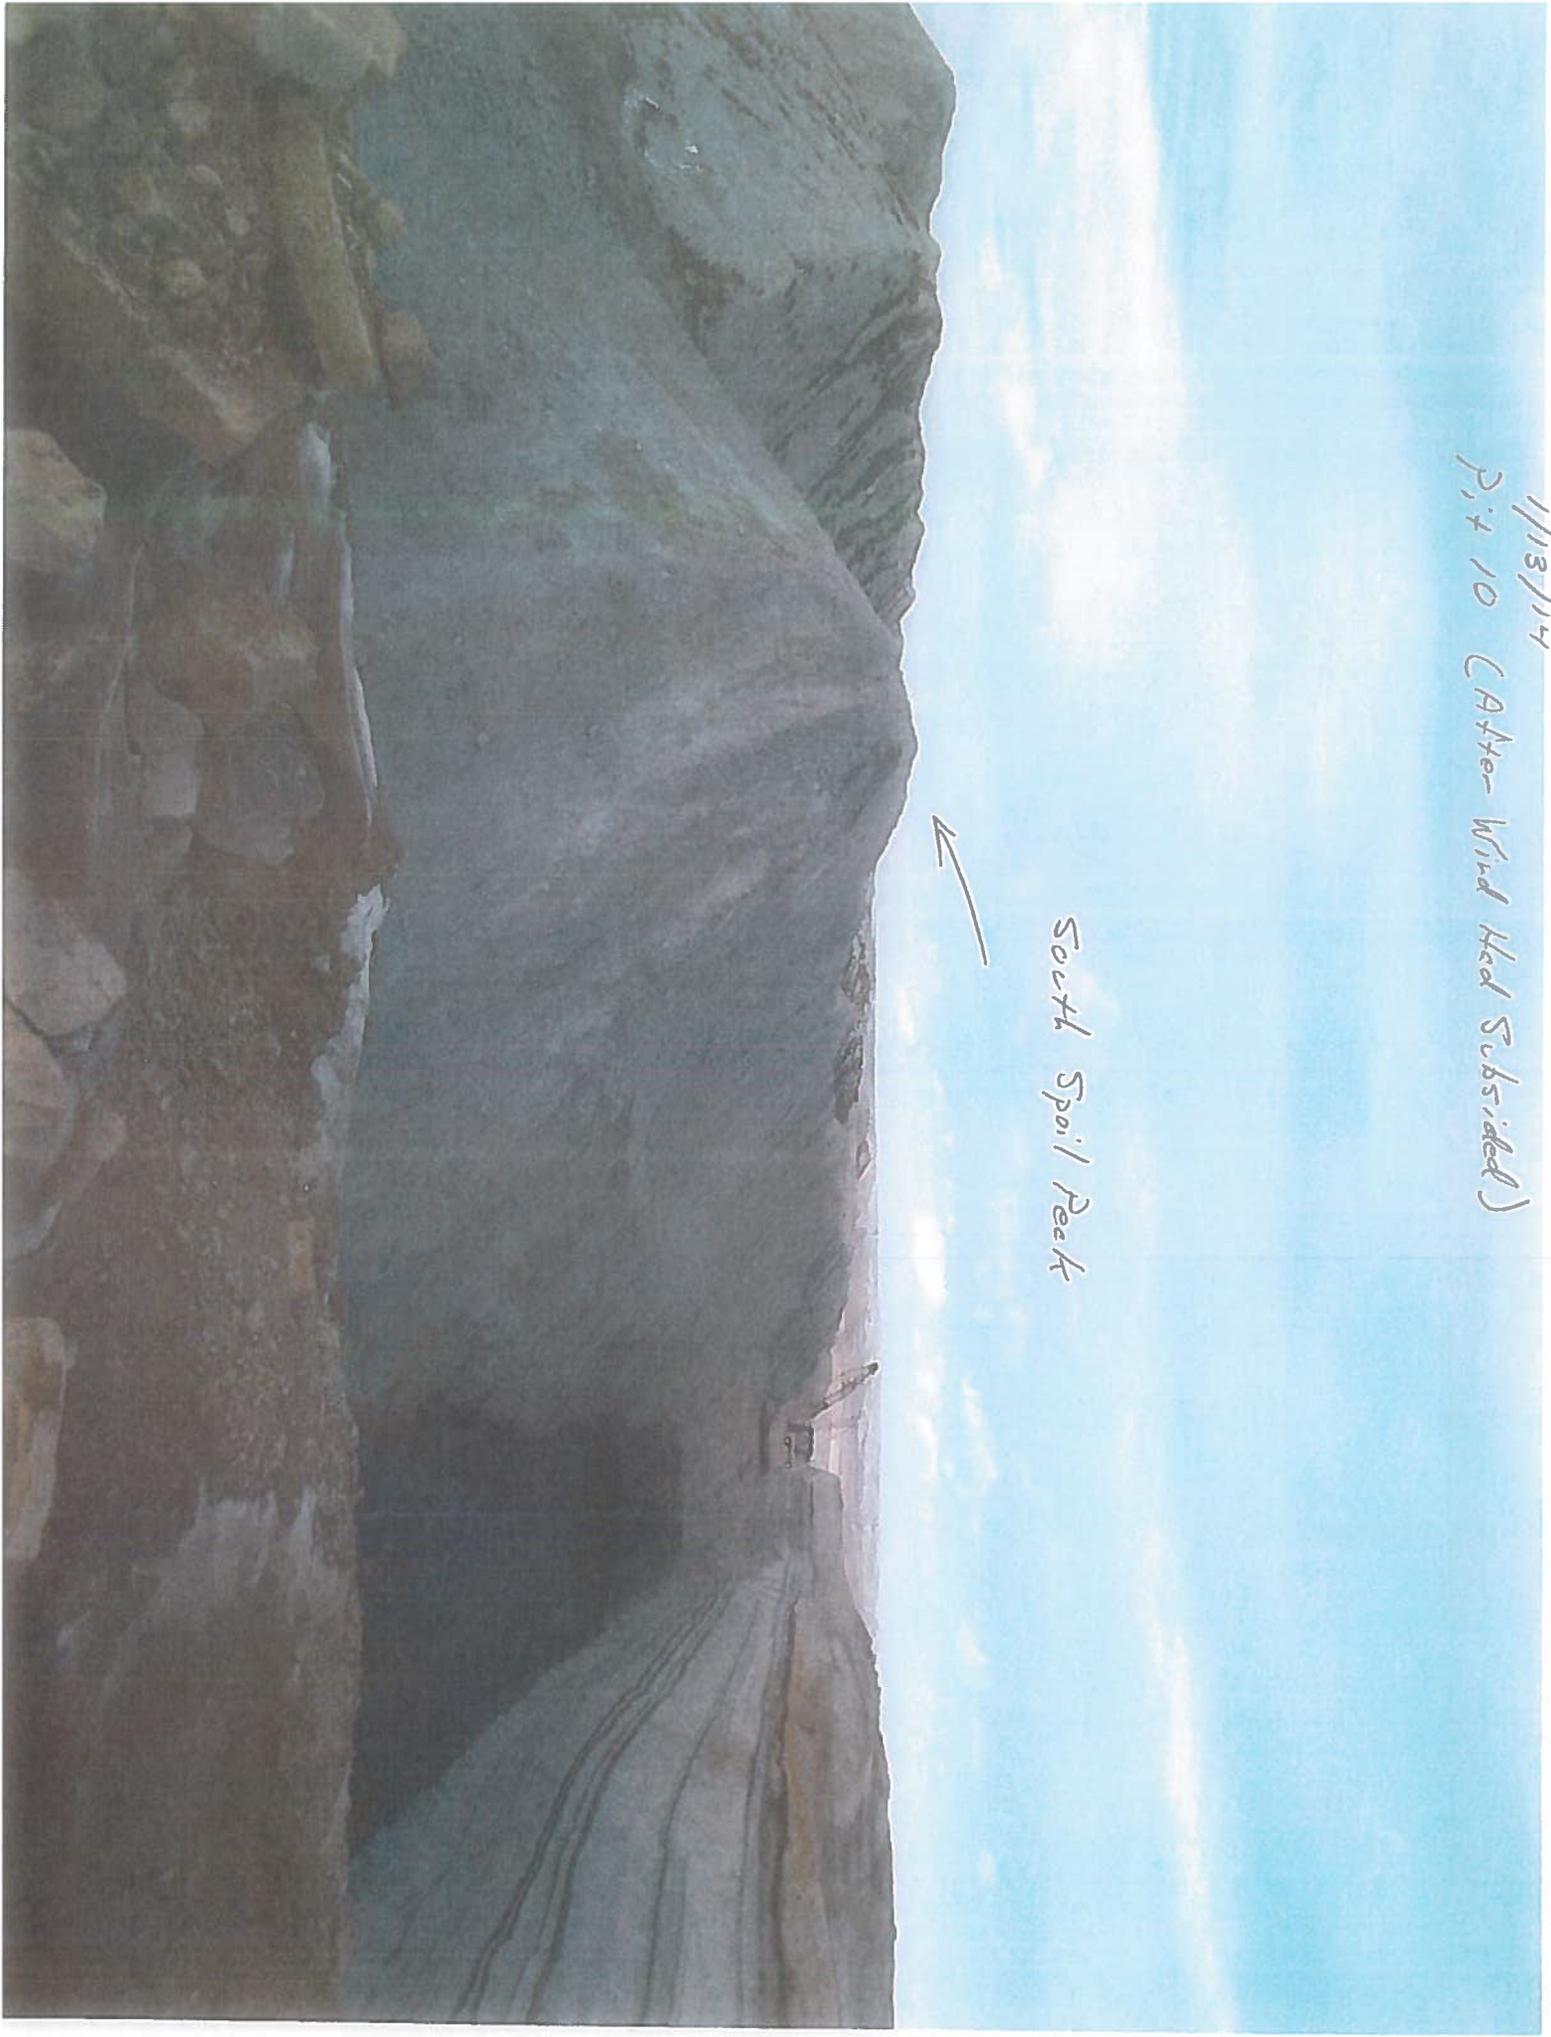
1/13/14
Pit 10 (After Wind Head Subsided)

South Spoil Bank
