APPENDIX L

SITE RECONNAISSANCE PHOTOGRAPHS

**APPENDIX L-1. HOLLAND CLEANERS SITE RECONNAISSANCE EXTERIOR PHOTOGRAPHS
LARAMIE 3RD STREET PCE ORPHAN SITE, LARAMIE, WYOMING**

Site Reconnaissance Exterior photographs collected 04/09/2014

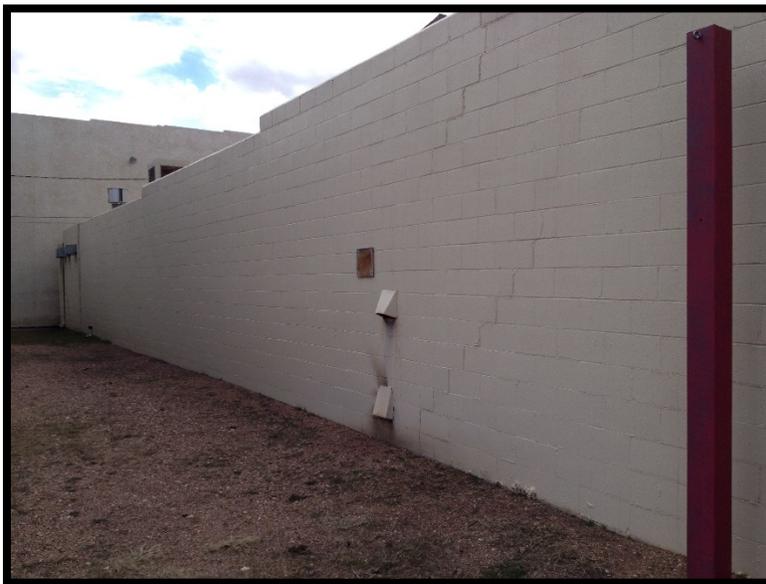
Picture 1.1: East facing exterior wall of Holland Cleaners. Several vents and drains can be seen along this wall.

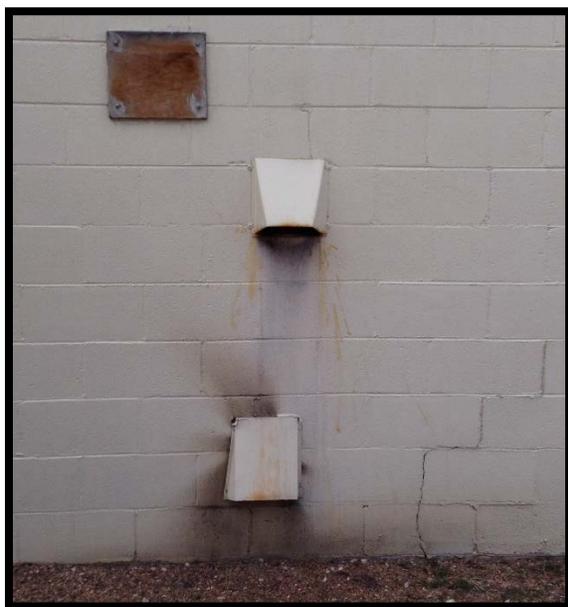
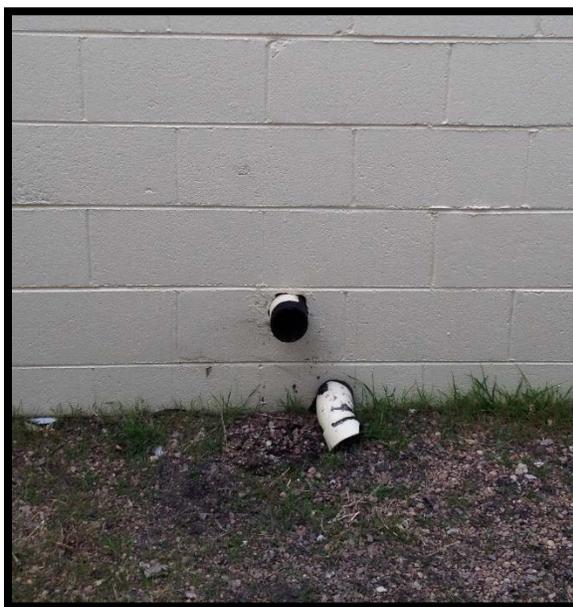
Picture 2.2: Vents and drains along the east facing exterior wall showing signs of staining, paint chipping, and buildup.

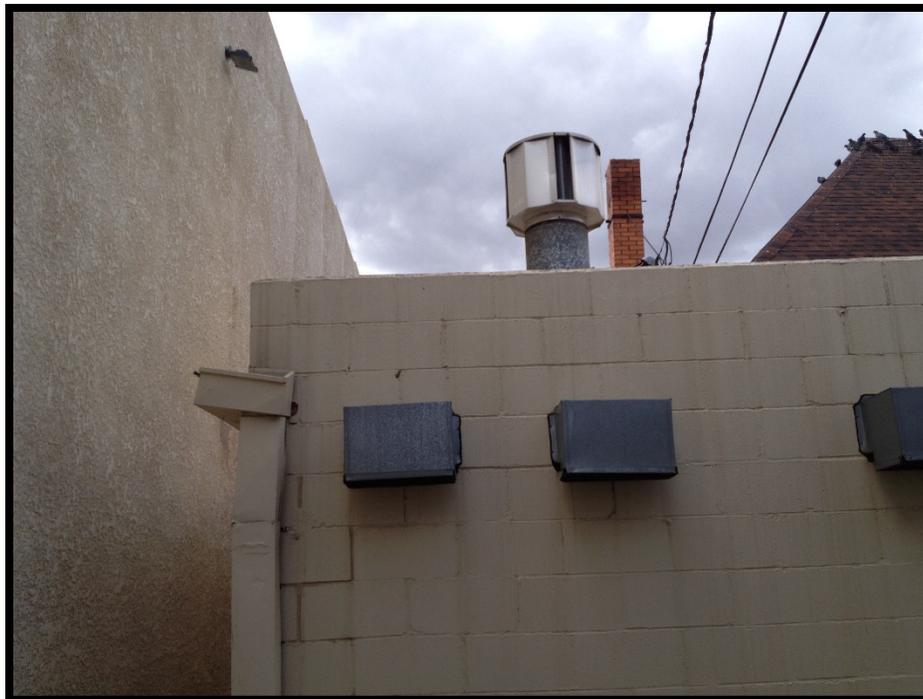
Picture 3.3: Vents and drains along the east facing exterior wall and roof. The building wall in the left of the photograph is north facing wall of the WYO Theater. Paint chipping that is shown in Picture 1.4 can be seen beyond the gutter drain.

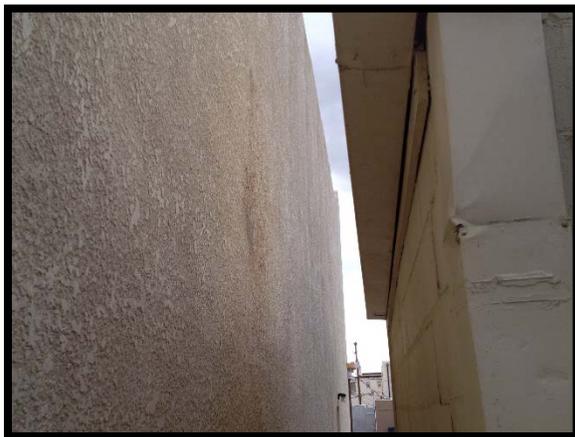
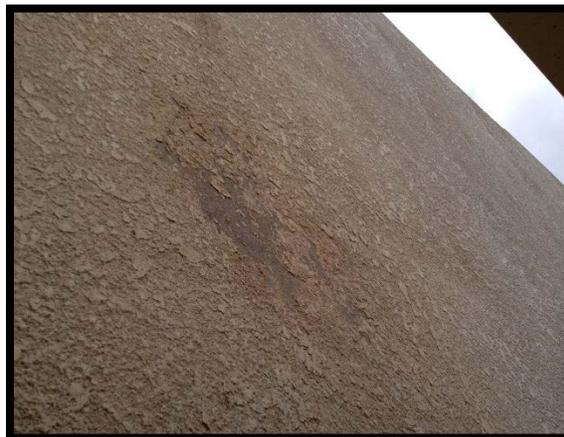
Picture 4.4: A spot of chipped paint on the north facing wall of the WYO Theater adjacent to the south wall of Holland Cleaners and near the roof mounted vents.

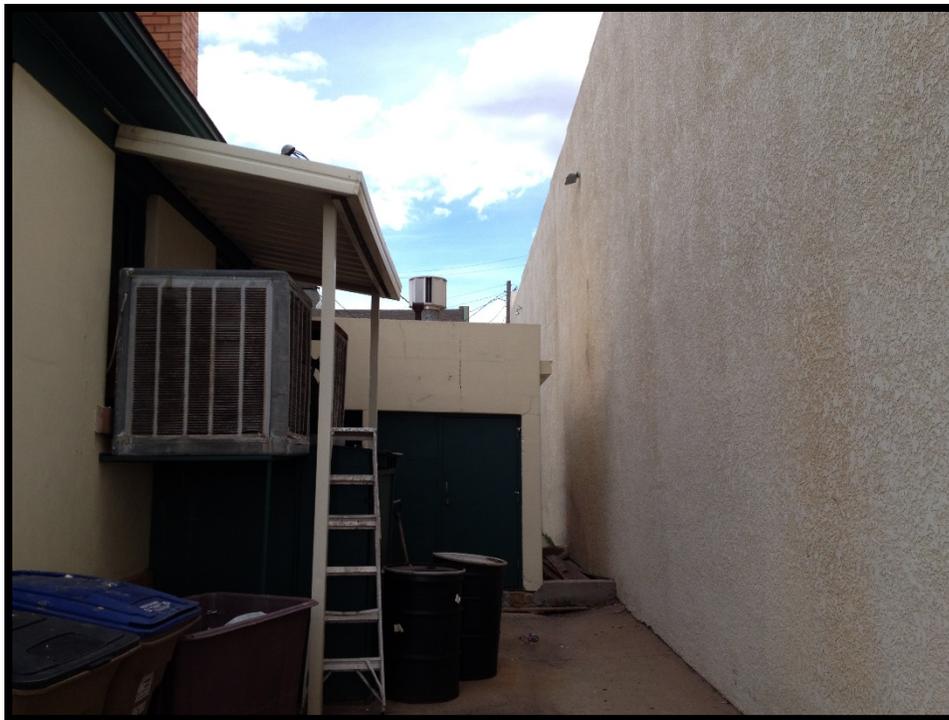
Picture 5.5: Facing east, looking at the west facing door of the boiler room. There were two unidentified 55 gallon drums (shown in Picture 1.6), one which was not fully sealed. The spot shown in Picture 1.4 can be seen at the right of this photograph.

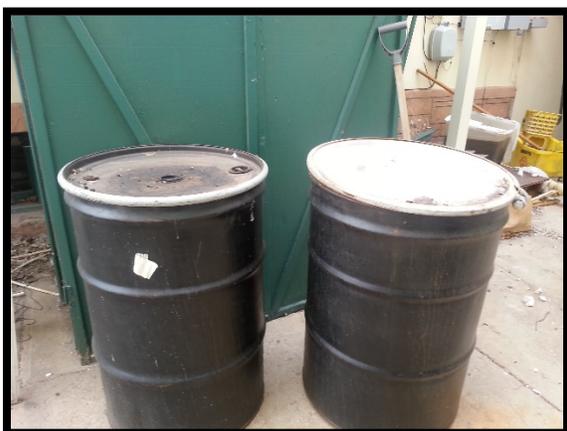
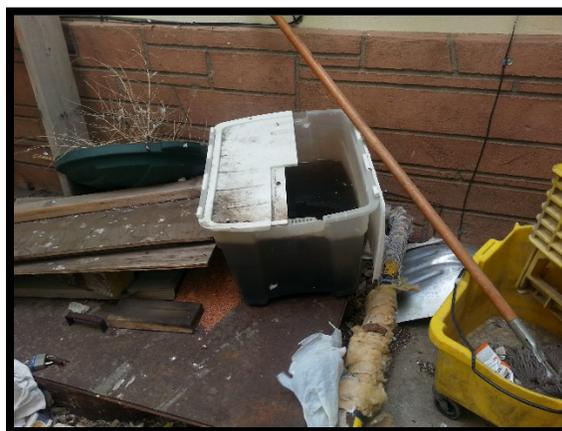
Picture 6.6: Two unidentified 55 gallon drums, a plastic 35 gallon container of unidentified sitting liquid, and municipal waste in front of the boiler room on the south side of the building.

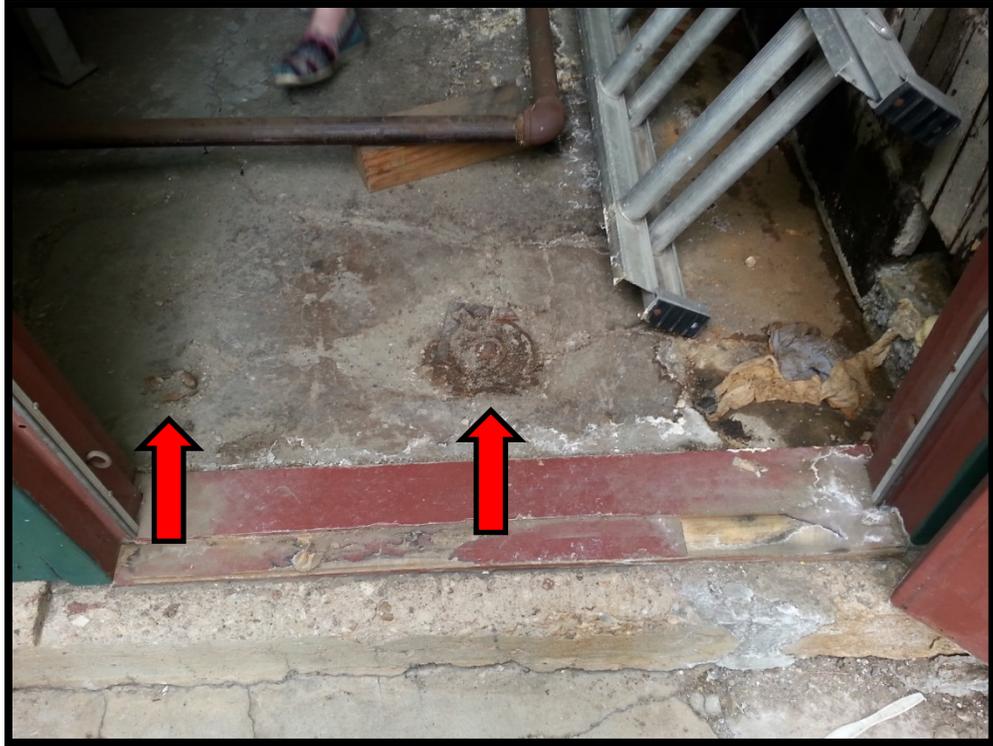
Picture 7.7: Capped and broken piping in the floor at the entrance to the boiler room on the south side of the property. Installed approximately 10 years ago, per Ms. Holland.

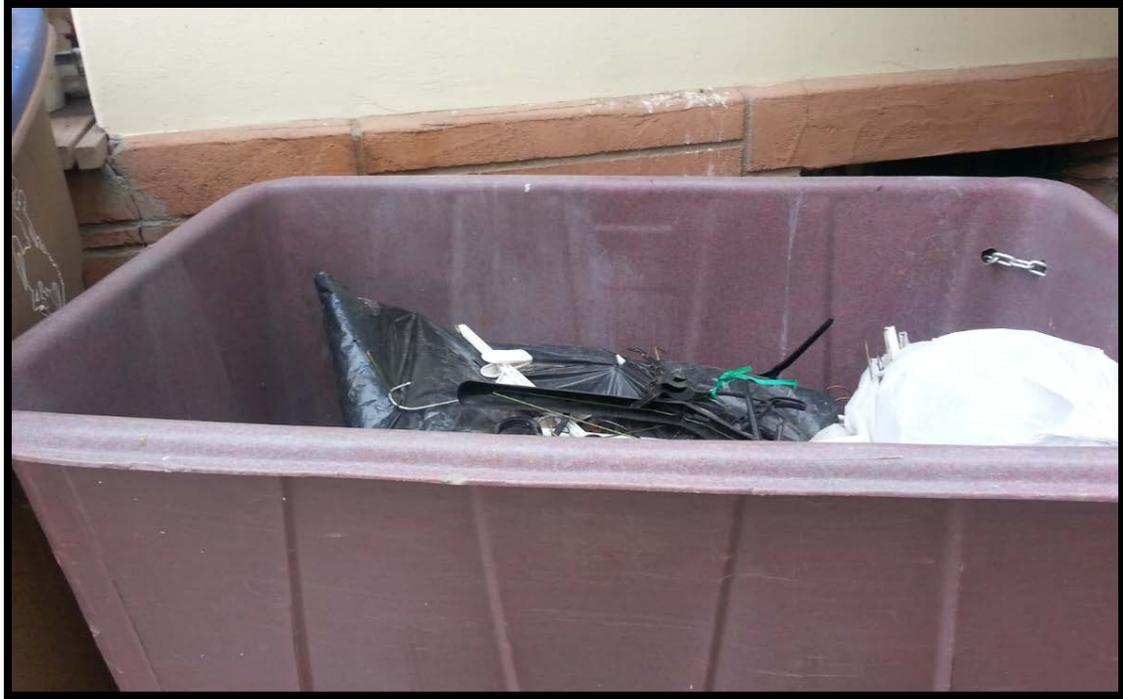
Picture 9.9: Municipal waste in front of the boiler room on the south side of the building.

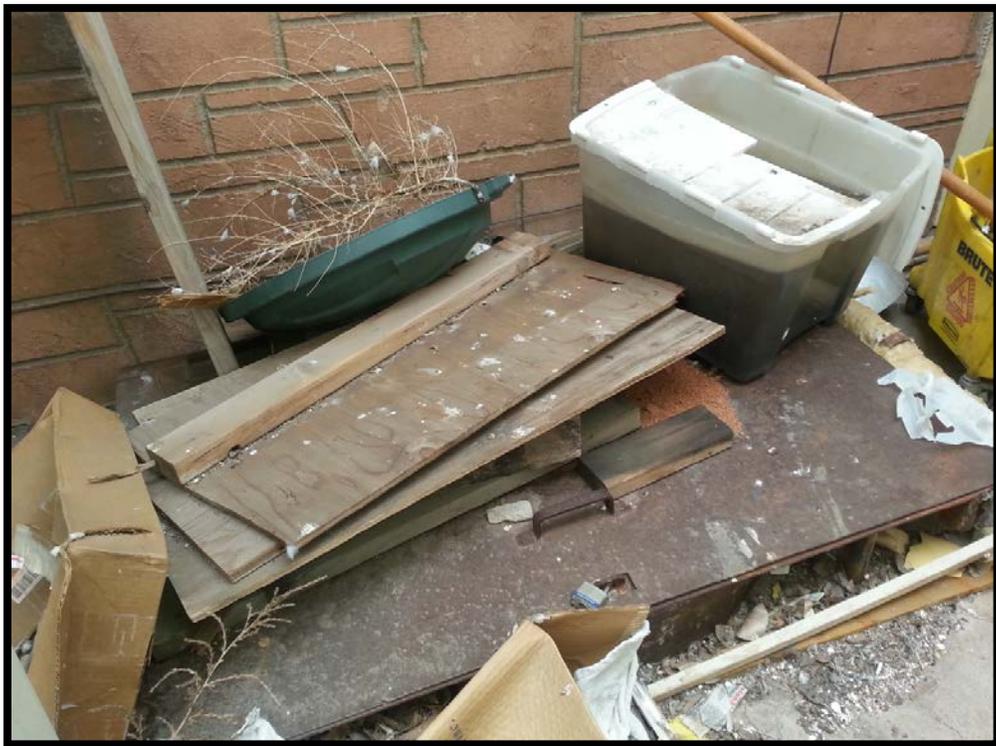
Picture 10.10: Municipal waste in front of the boiler room on the south side of the building on top of a locked unknown vault.

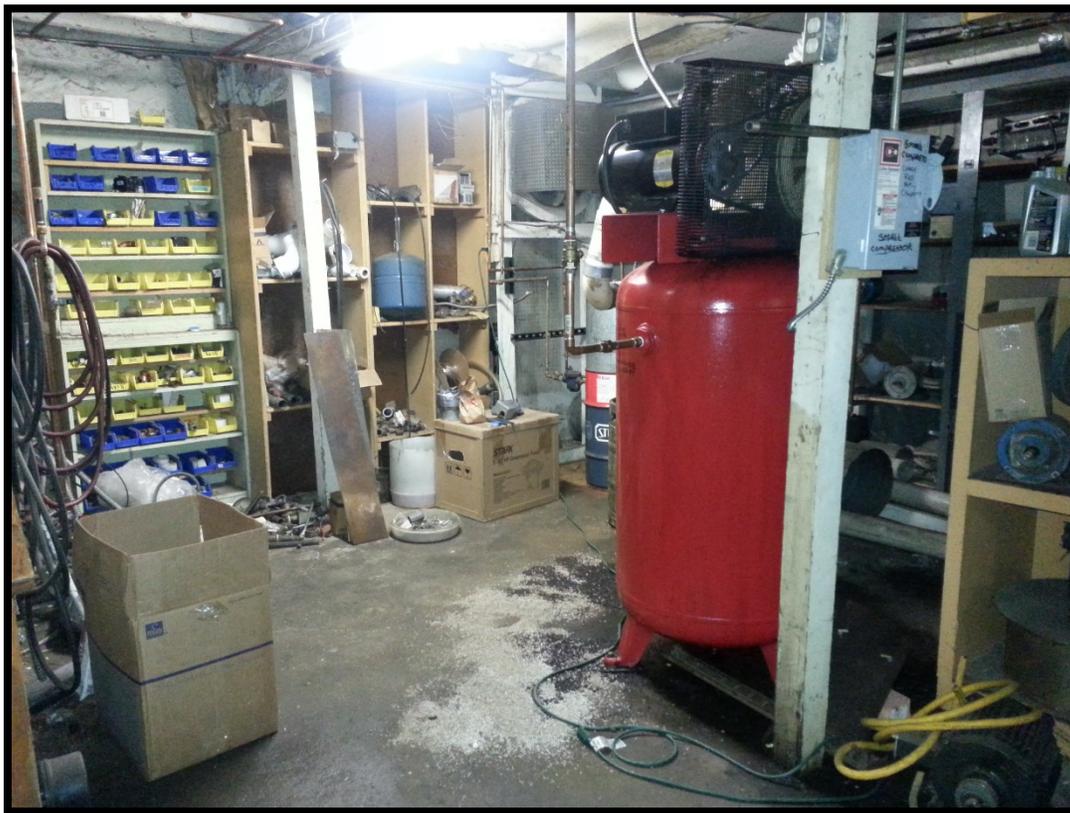
Picture 2.1: Air compressor unit with a spill that has been covered in an absorbent.

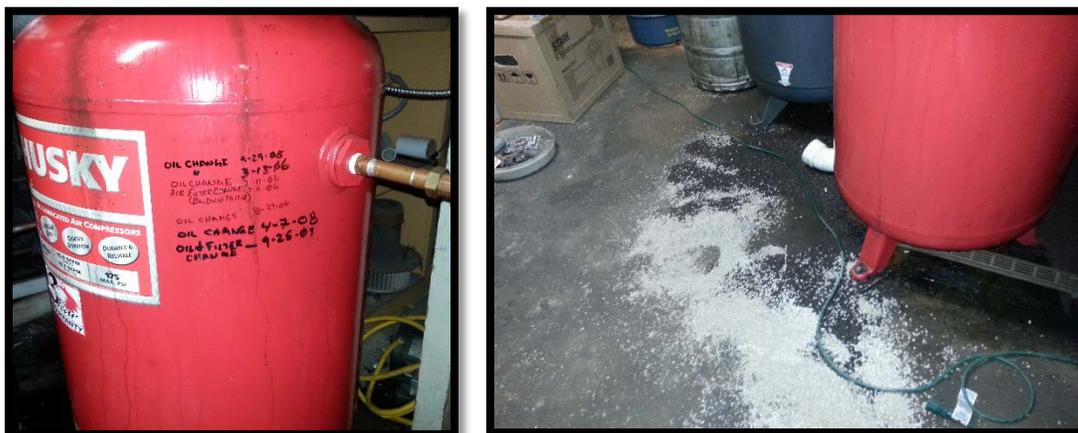
Picture 2.2: The air compressor shown in Picture 3.1. The photograph on the right shows another angle of the spill that was covered in an absorbent.

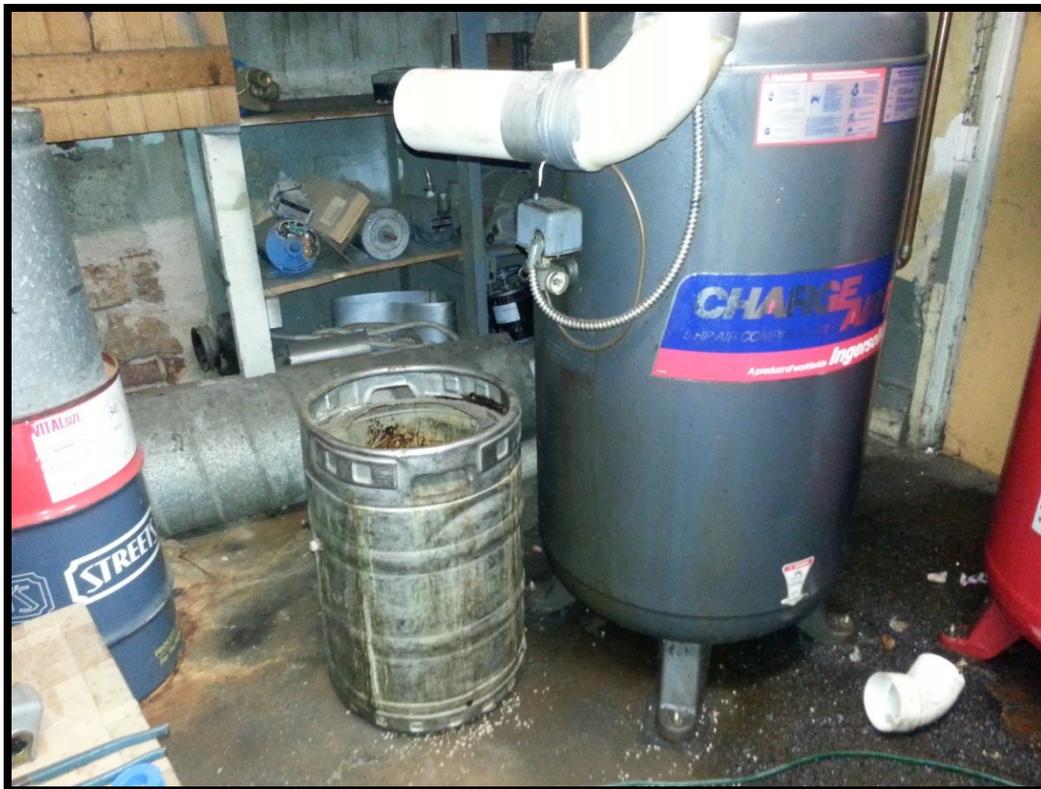
Picture 2.3: A second air compressor located above the oil spill that was covered in an absorbent. In the center of this photograph there is a 15.5 gallon beer keg that has had the top cut off. On the left side of the photograph there is a sealed drum (approximately 30 gallons) underneath another drum with an open top.

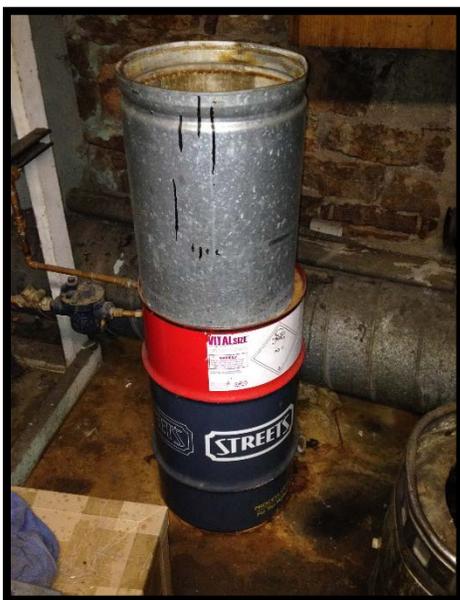
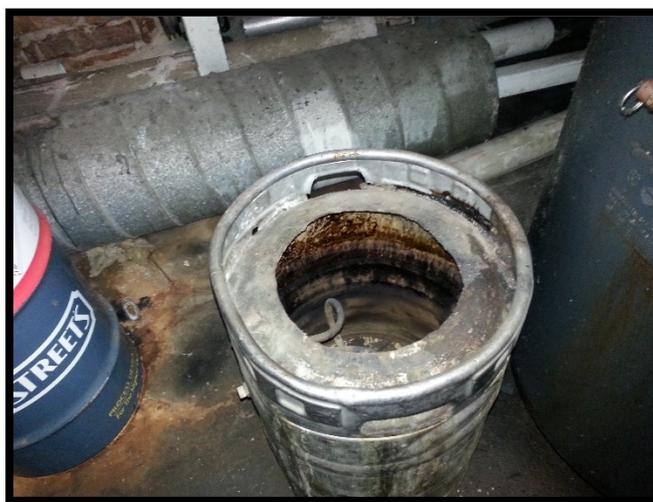
Picture 2.4: The stacked drums and the converted beer keg shown in Picture 3.3.

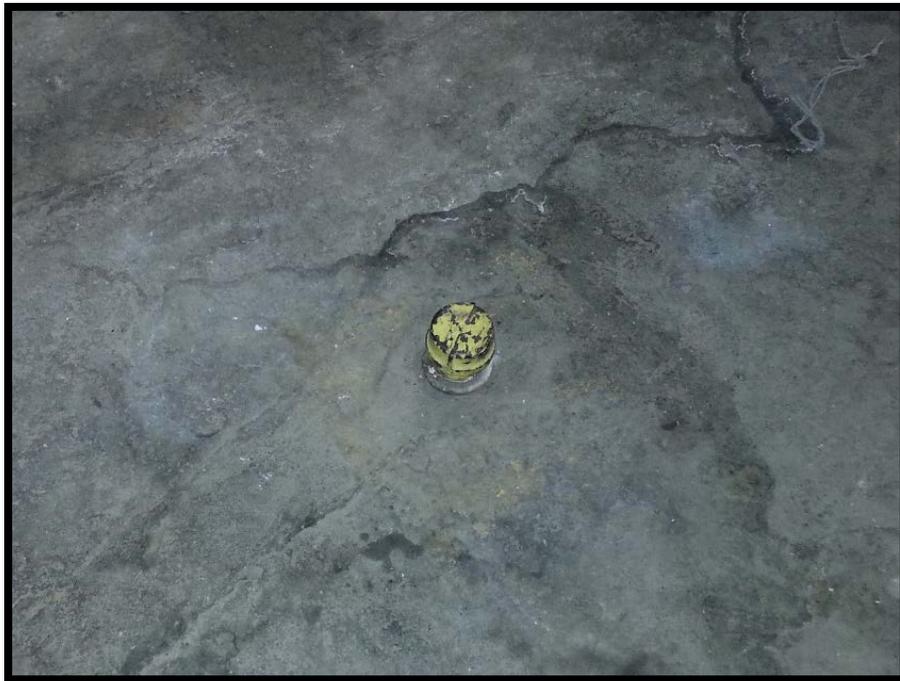
Picture 2.6: A capped pipe sticking out of the basement floor.

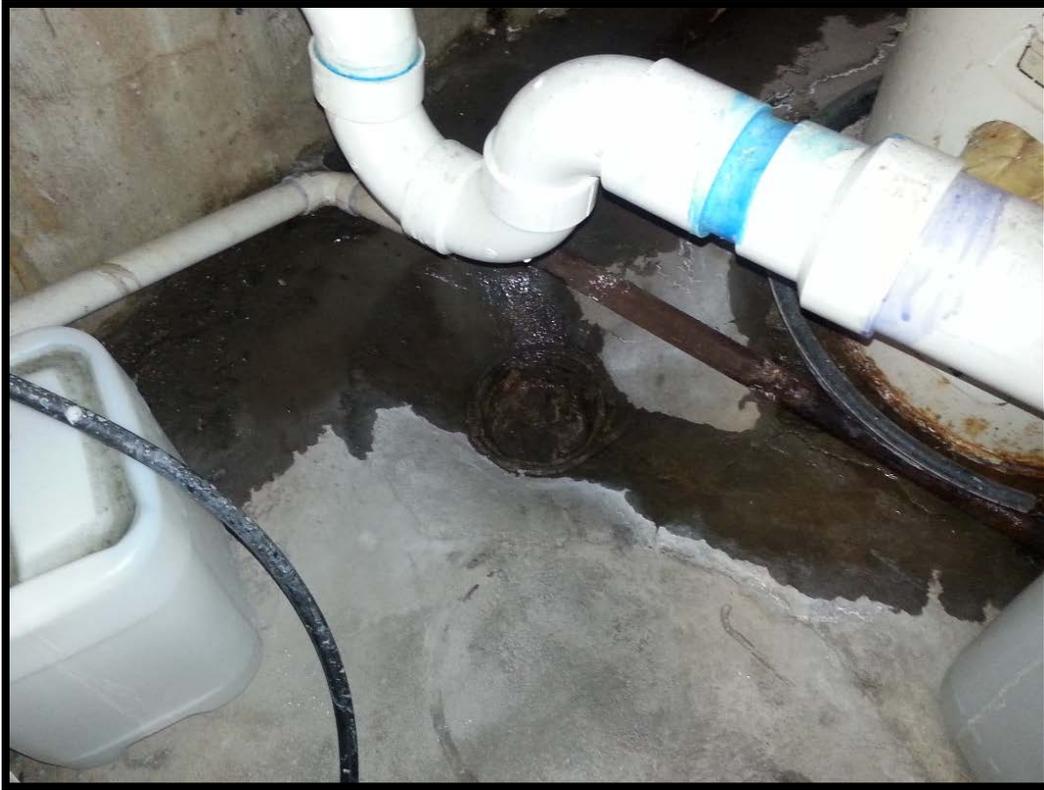
Picture 2.7: A drain along the east wall of the basement which appeared to have a dark liquid draining

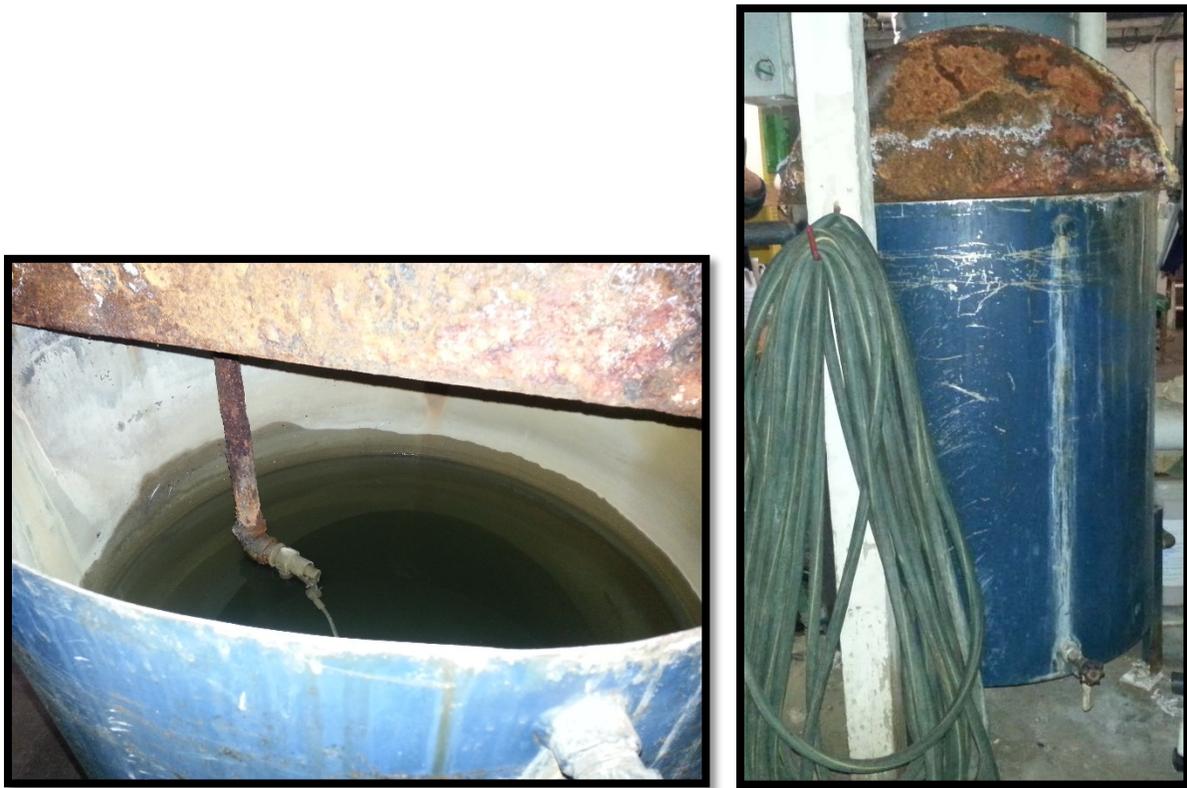
Picture 2.9: A large tank containing an unknown liquid.

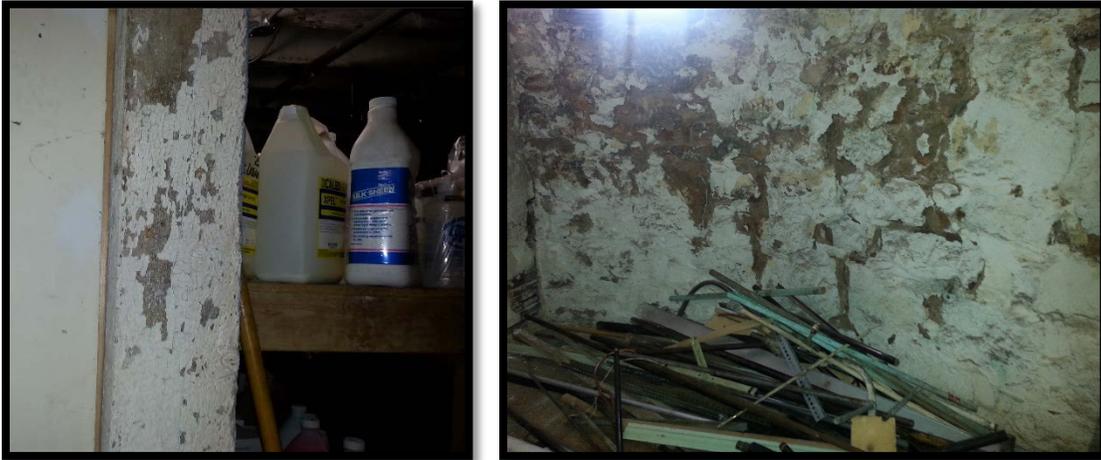
Picture 2.11: Chipped and peeling paint on the basement walls and trim.

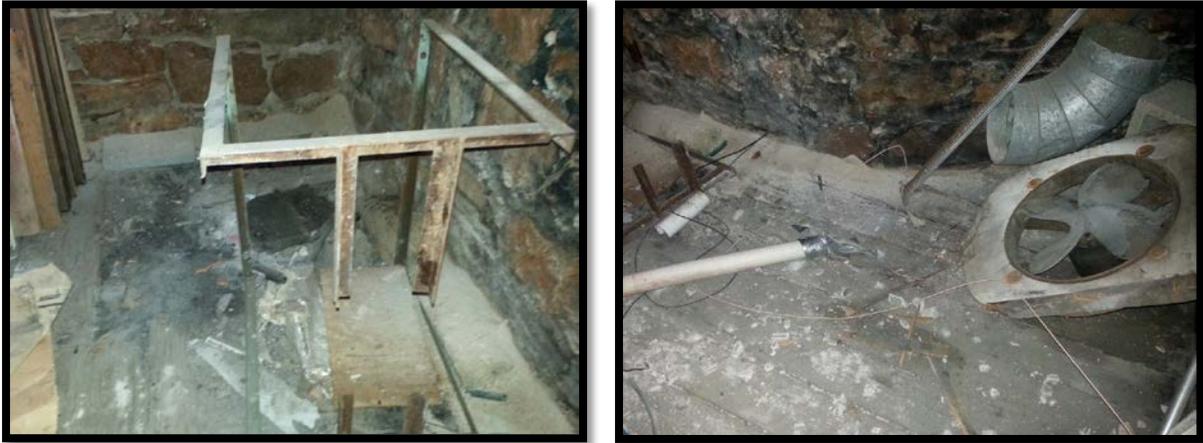
Picture 2.13: Old wood flooring in a room on the west side of the basement with evidence of staining.

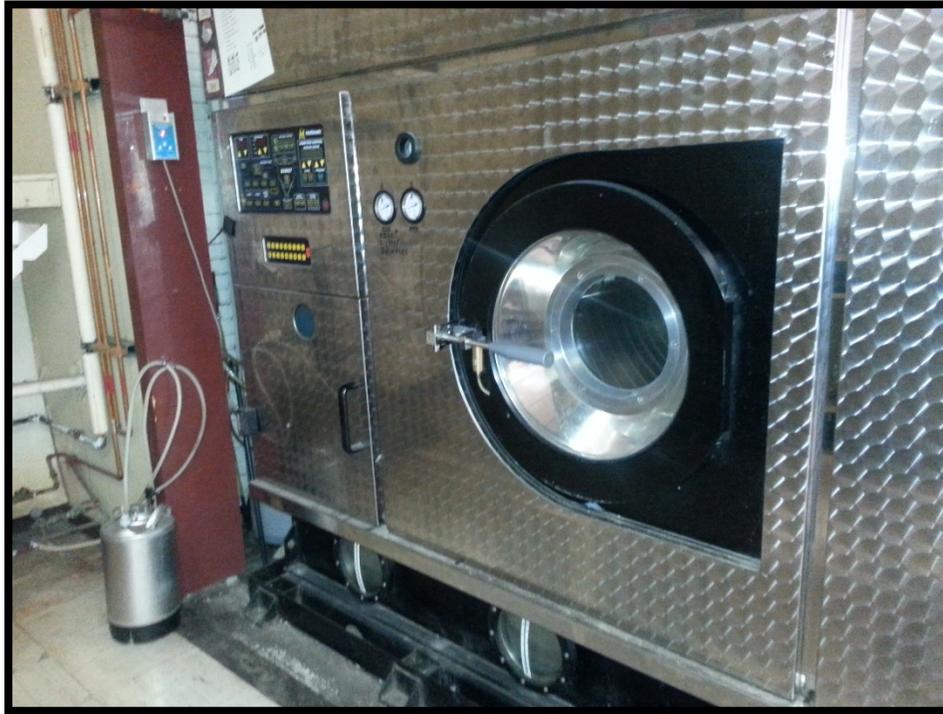
Picture 3.1: Front access of dry cleaning machine. Holland Cleaners representative noted there may still be PCE in the machine.

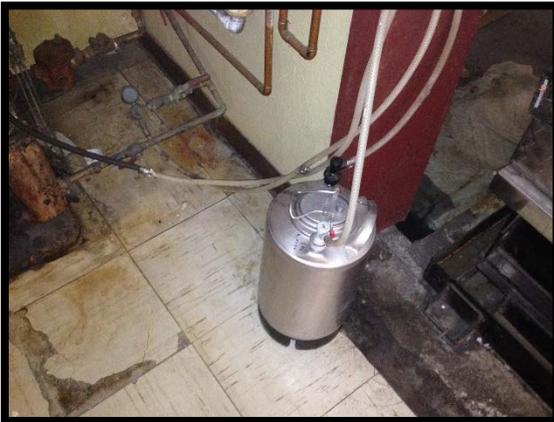
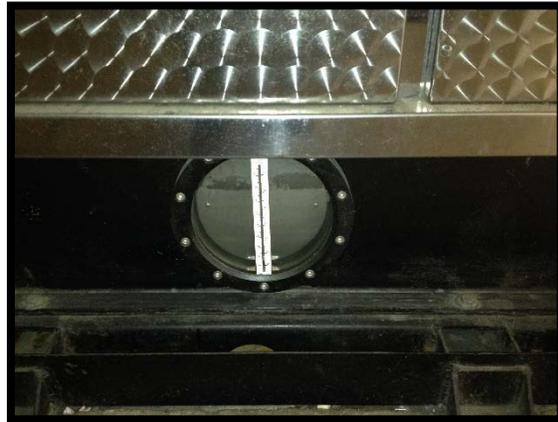
Picture 3.2: 3 gallon Cornelius Keg filled with unknown substance. Sight glass for PCE storage in the large dry cleaning machine shown in Picture 2.1.

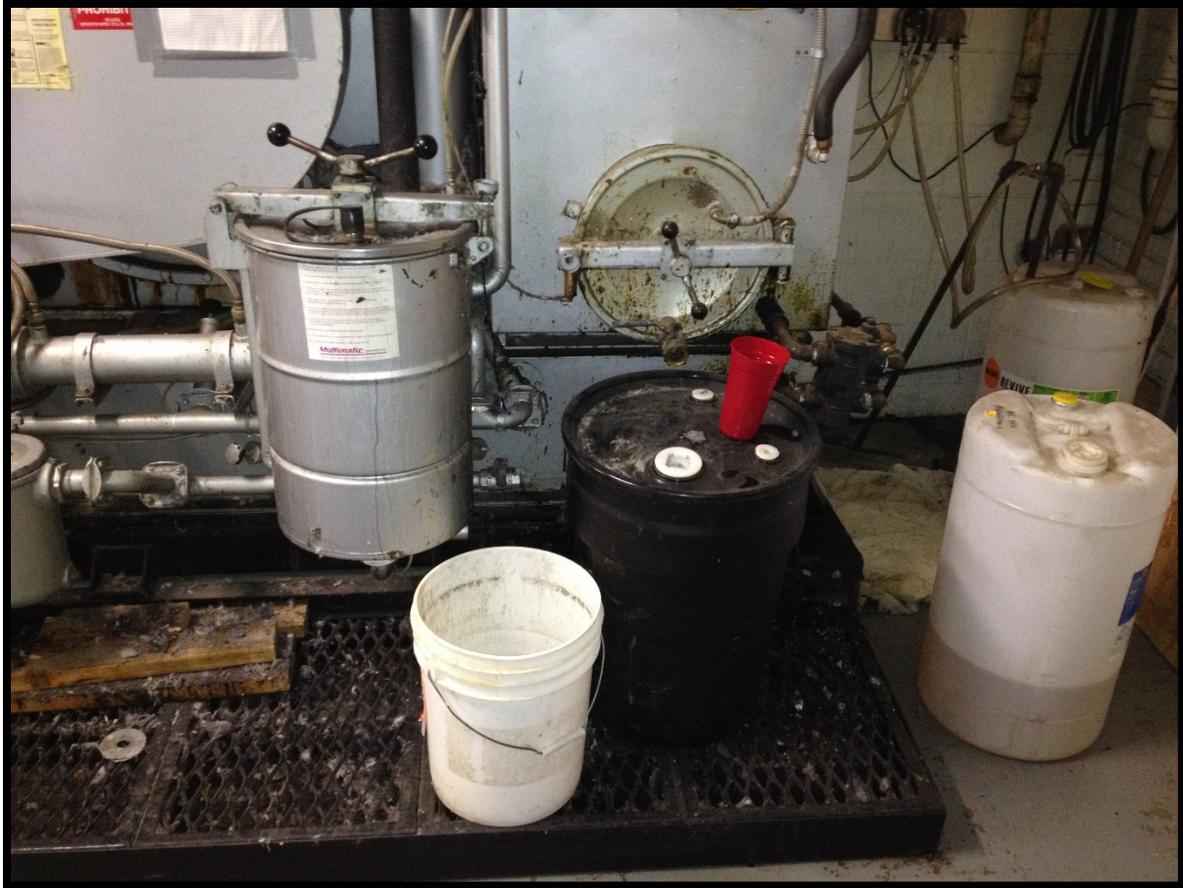
Picture 3.3: Rear access to the large dry cleaning machine. There are two plastic barrels (approximately 15 gallons capacity) that were less than half full containing an unknown substance and one 30 gallon drum likely containing PCE per the Holland Cleaner representative.

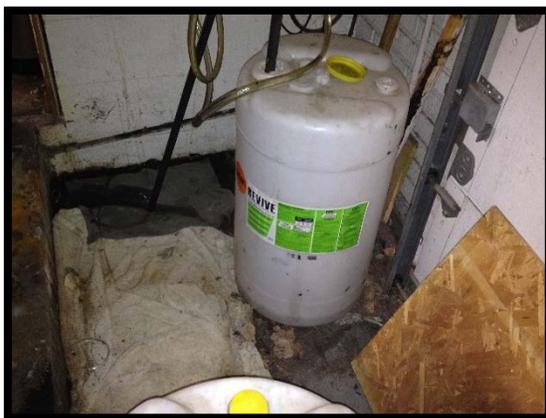
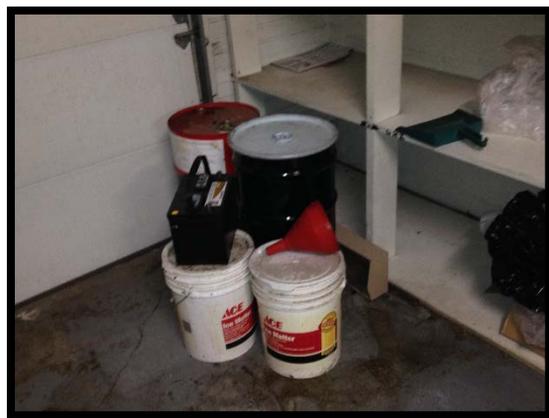
Picture 3.4: A closer picture of the plastic barrel shown in Picture 2.3. The photograph on the right shows two drums (approximately 15 gallon capacity) likely containing waste product per the Holland Cleaner representative.

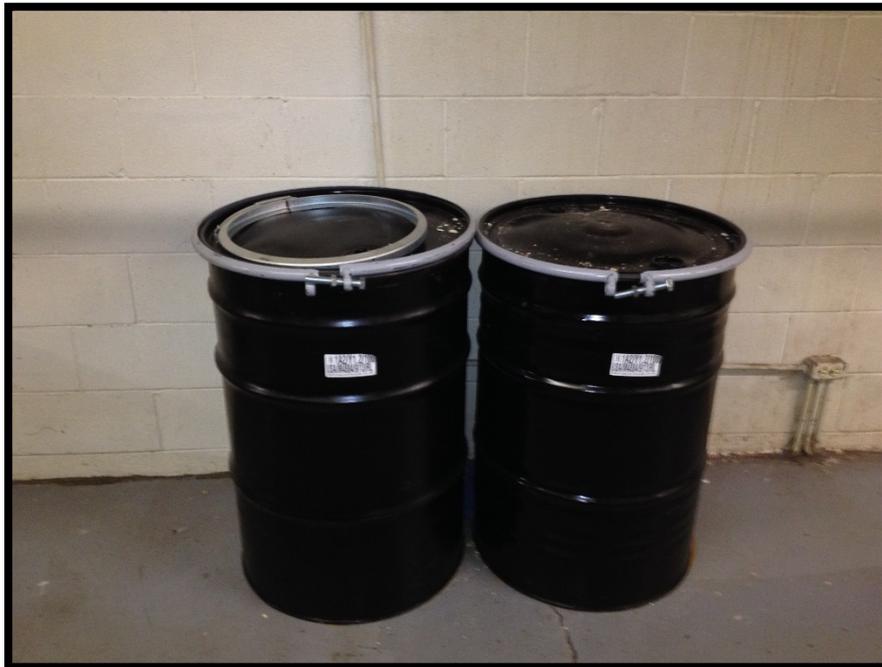
Picture 3.6: Two unidentified 55 gallon drums.

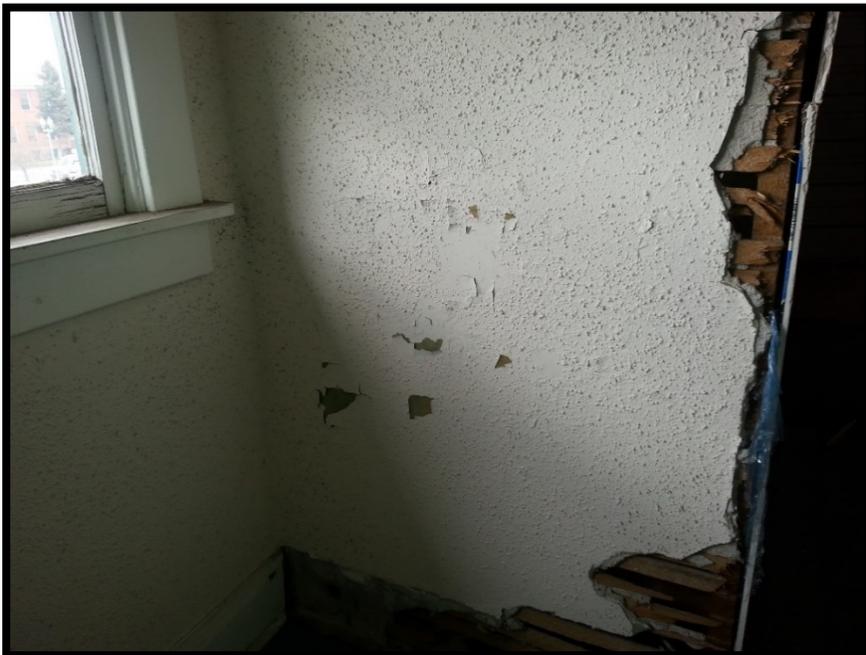
Picture 4.2: Chipped and peeling paint on walls and windows of the second floor. Potential asbestos containing materials on wall.

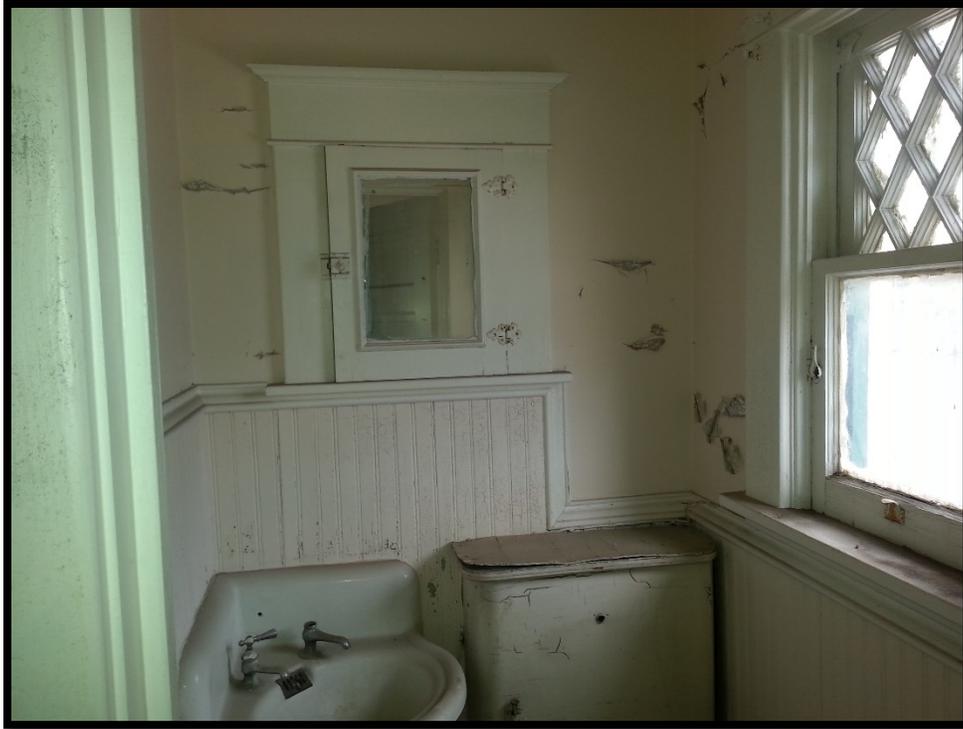
Picture 4.3: Chipped and peeling paint on walls and windows of the second floor bathroom.

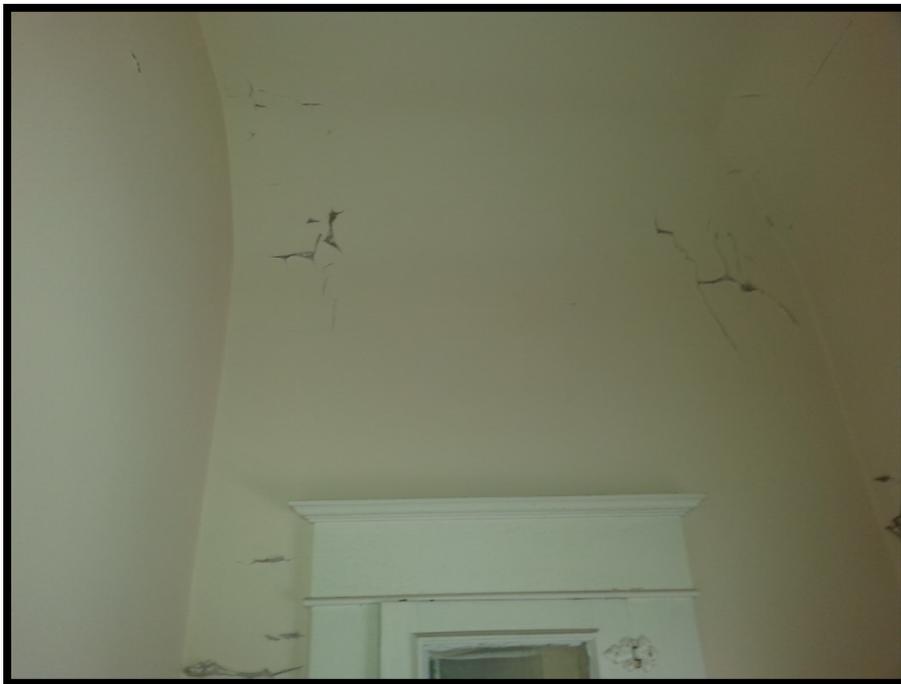
Picture 4.4: Chipped and peeling paint on walls and ceiling of the second floor bathroom.
