**FORMER LOBELL REFINERY  
EXPANDED INVESTIGATION  
AND SVE PILOT STUDY REPORT**

Former Lobell Refinery-Orphan  
Site Remediation Program (OSRP)  
File 57.004  
CASPER, WYOMING

November 26, 2014

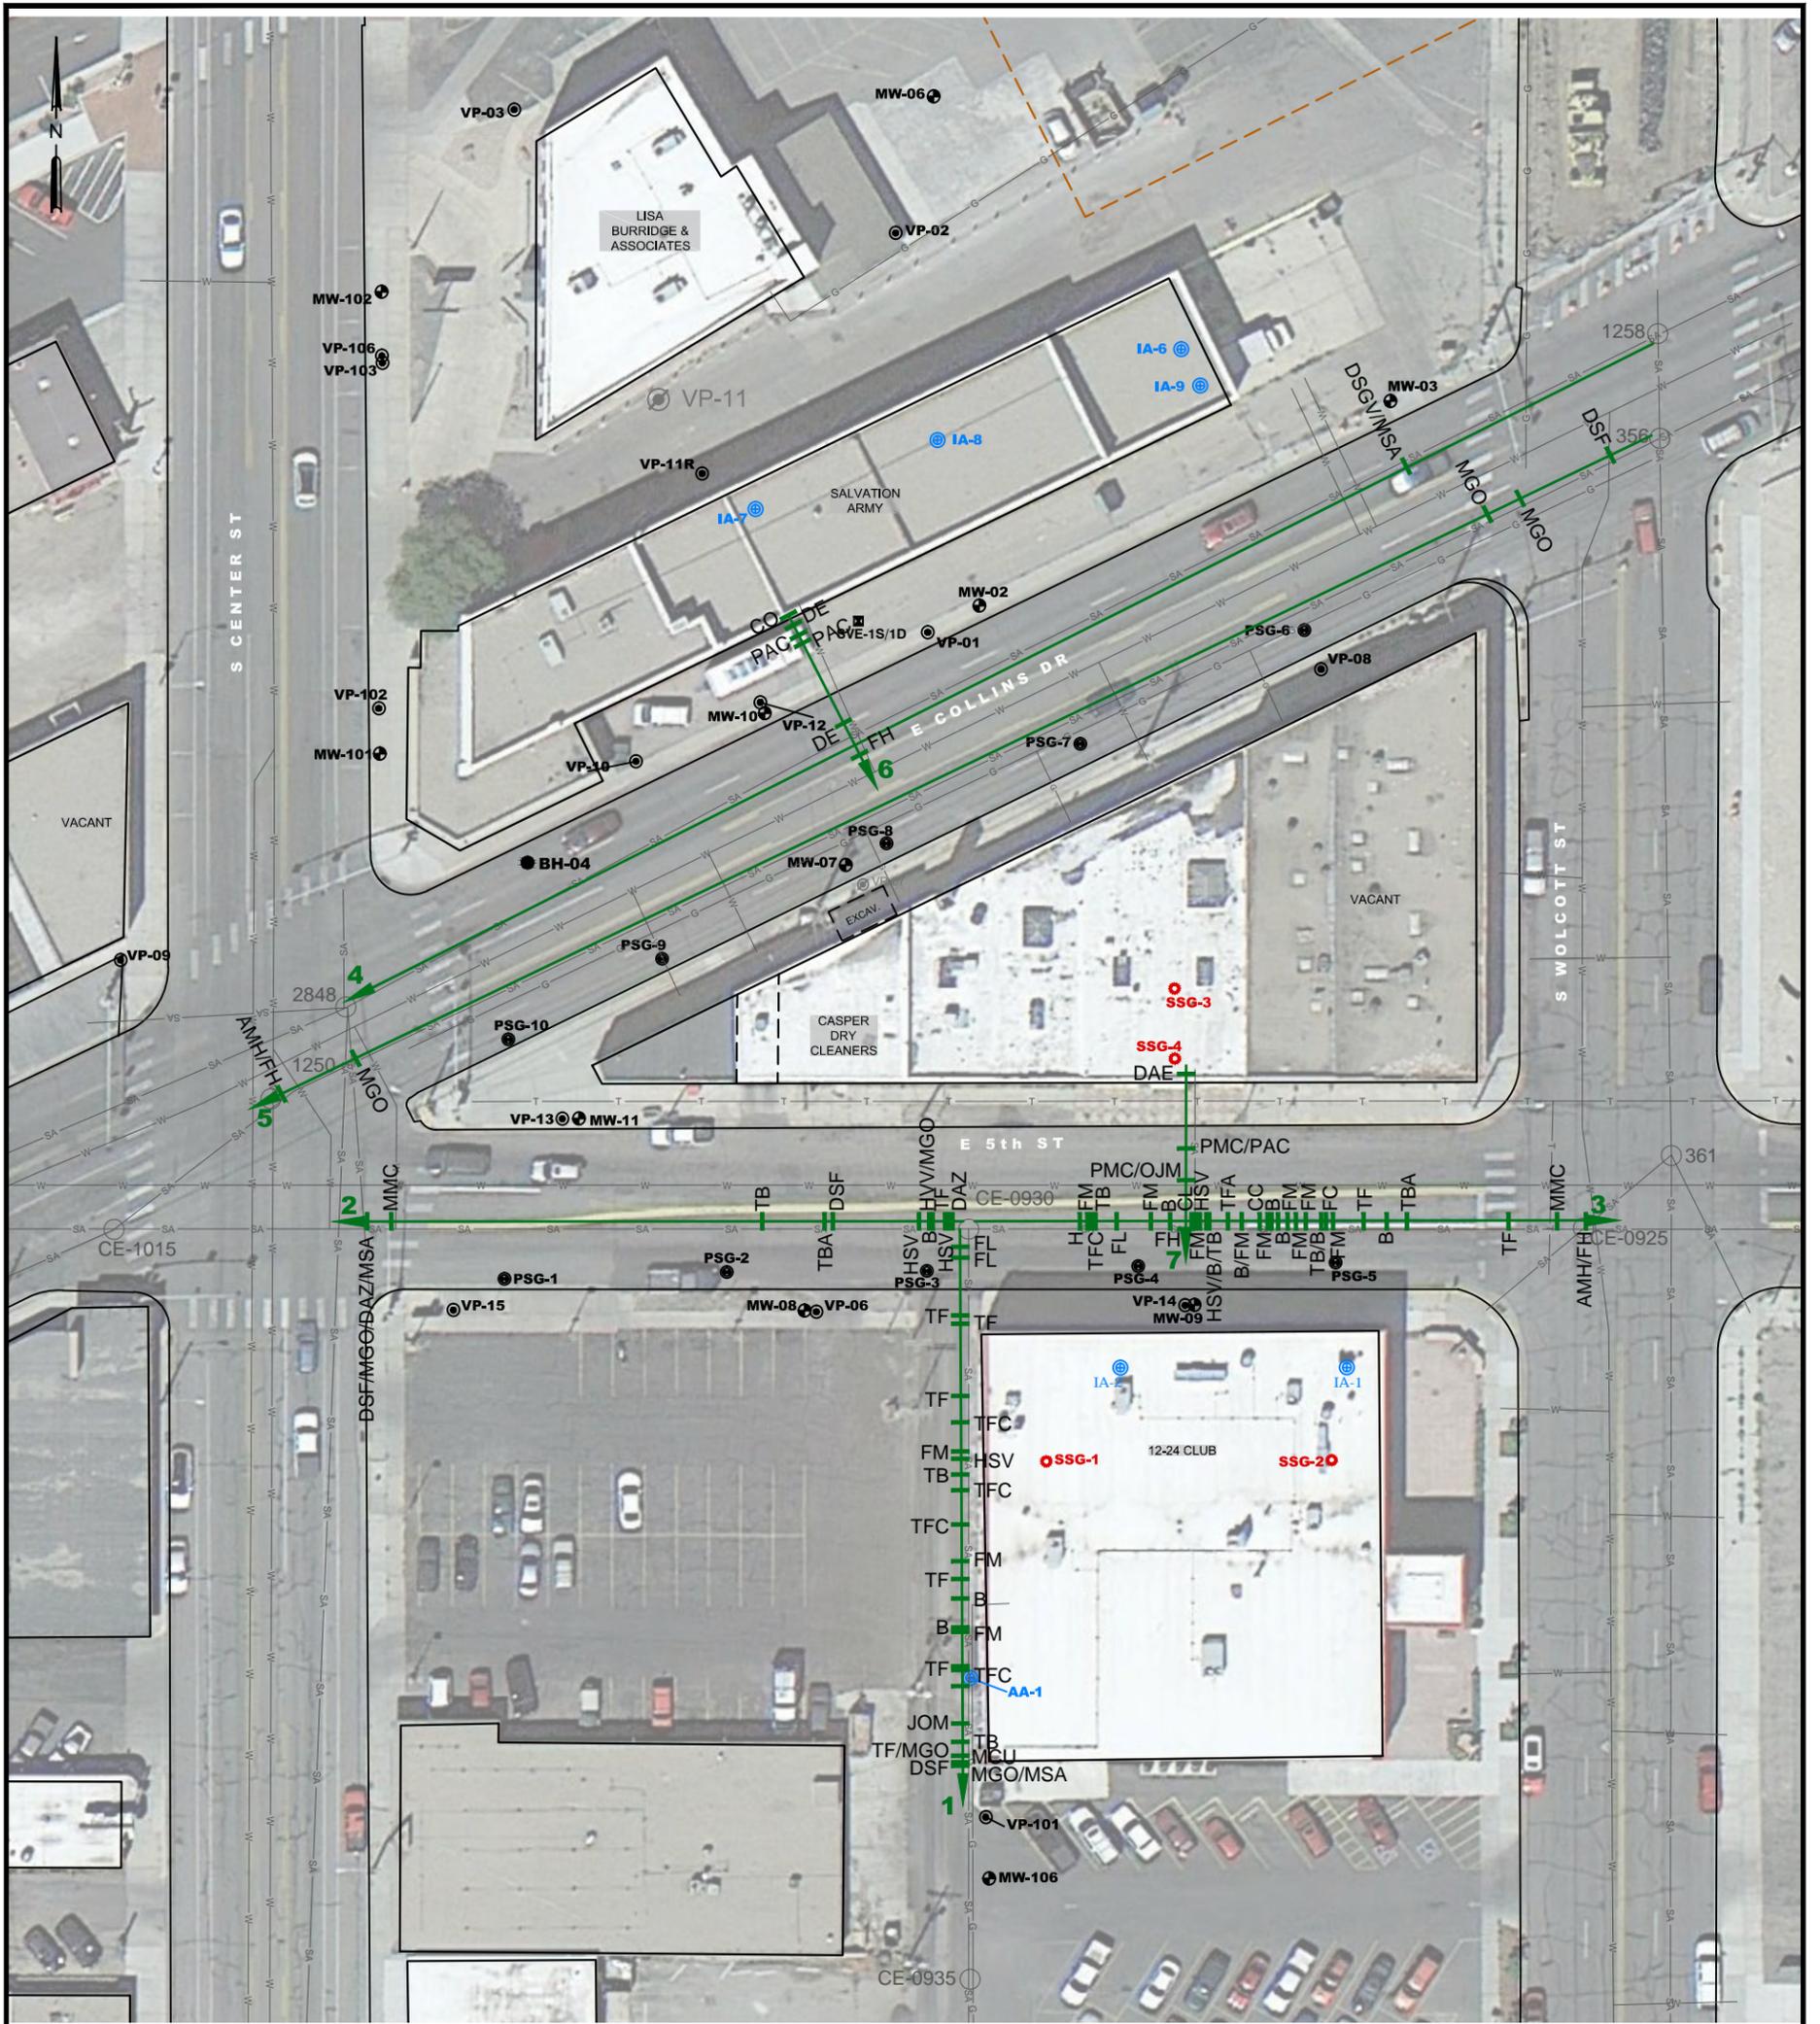
- Run Number 1: Starting at sanitary sewer manhole CE-0930 headed south (upstream) 151.1 feet toward manhole CE-0935
  - Sewer line constructed of vitrified clay pipe
  - Longitudinal fractures at 4.7 and 7.9 feet
  - Hole and soil visible at 64.5 feet
  - Multiple fractures at 62.2, 93.5, and 112.1 feet
  - Broken pipe at 103.9 and 109.1 feet

- Run Number 2: Starting at sanitary sewer manhole CE-0930 headed west (upstream) 168.4 feet toward manhole CE-1015
  - Sewer line constructed of vitrified clay pipe (0-161.7 feet) and PVC (161.7-168.4 feet)
  - Hole and soil visible at 5.1, 10.3, and 13.5 feet
  - Broken pipe at 10.1 feet

- Hole at 30.8 feet
  - Multiple fractures at 33.1, 63.6, 76.2, 83.7, 89.2, 91.5, 94.3, and 101.9 feet
  - Broken pipe at 56.1, 66.8, 76.2, 84.2, 86.5, 98.7, and 117.0 feet

- Longitudinal crack at 62.5 feet
  - Multiple fractures at 63.6, 76.2, 89.2, 91.5, 94.3, and 101.9 feet
  - Hole and soil visible at 64.0 and 66.7 feet

- Circumferential crack at 81.4 feet
  - Circumferential fracture at 99.5 feet
- Run Number 4: Starting at storm sewer manhole 1258 headed west 77.4 feet toward manhole 2848

The sewer lines in the vicinity of the 12-24 Club building are generally in poor condition as described for Runs 1 and 3 in this report. Those areas where the sanitary sewer is breached represent locations of possible sources. The locations of these breaches also coincides with the location of PCE impacts present in soil vapor and groundwater near the northeast corner of the 12-24 Club building and on the passive soil gas survey presented in the Draft Expanded Investigation and Underground Storage Tank (UST) Excavation/In-Situ Abandonment Report (Stantec, 2014). Thus, the area north of the 12-24 Club building appears to be a focus area for additional investigation in the form of monitoring and/or remediation wells. Since this investigation was focused on examining the location, condition, and distribution of the sewer lines, the condition of dry cleaning equipment and PCE storage practices were not emphasized. . It should be noted that breached sewer lines could potentially transmit soil vapors by releasing liquids or

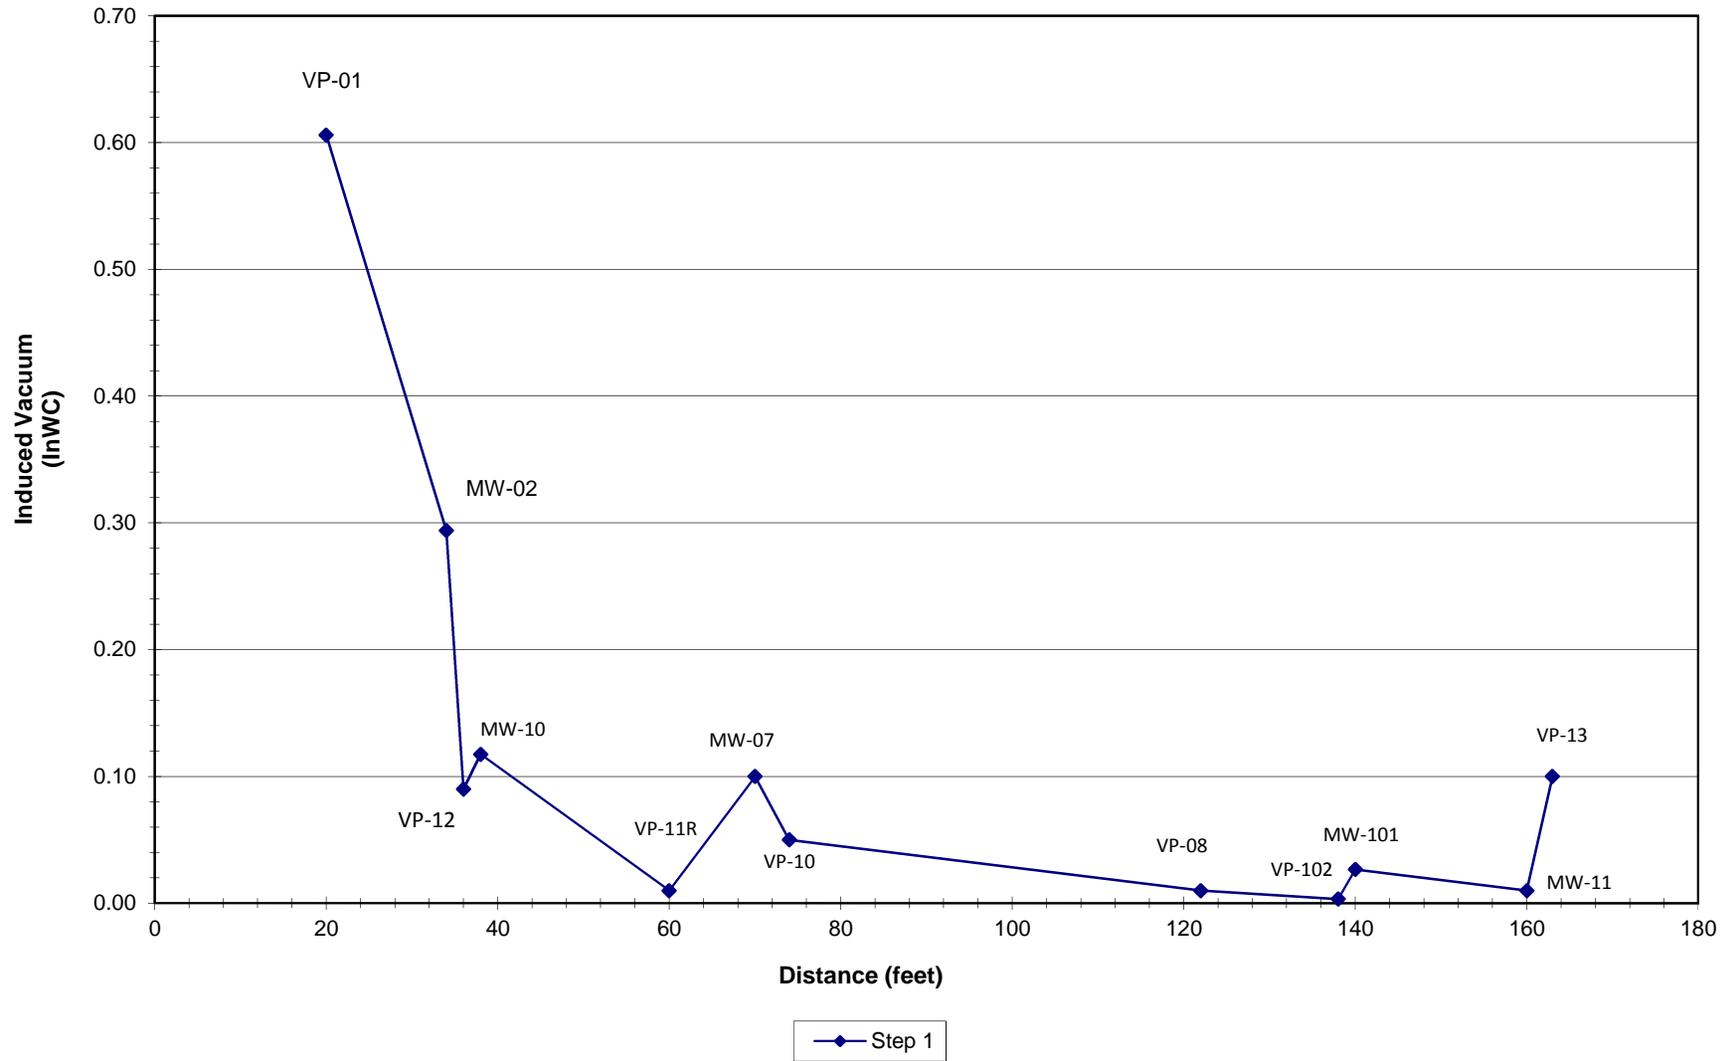
GRAPH 1  
SVE Pilot Study -Average Induced Vacuum vs. Distance from SVE-1S /1D  
Former Lobell Refinery-Orphan Site Remediation Program (OSRP) File 57.004  
Casper, Wyoming  
Stantec Project NO. 212205045

The EM 1110-1-4001 (US Army Corps Engineers, June 2002), indicates that 1,000 to 1,500 PVEs are typically needed for remediation, unless initial concentrations are relatively high or cleanup goals are relatively low. Given that magnitude of VOC concentrations at certain areas throughout the Site, a target value of approximately 2,190 PVEs (3.0 PVE per day) is recommended as the targeted exchange rate. Based on utilizing the PVE method and the calculations presented on Table 7, the initial SVE Pilot Study indicates that the effective ROI is approximately 91 to 110 feet.

- It is recommended that the more conservative ROI estimated value of 40 feet, evaluated by induced vacuum measurements at the various observation wells, is utilized during full-scale design of an SVE system.

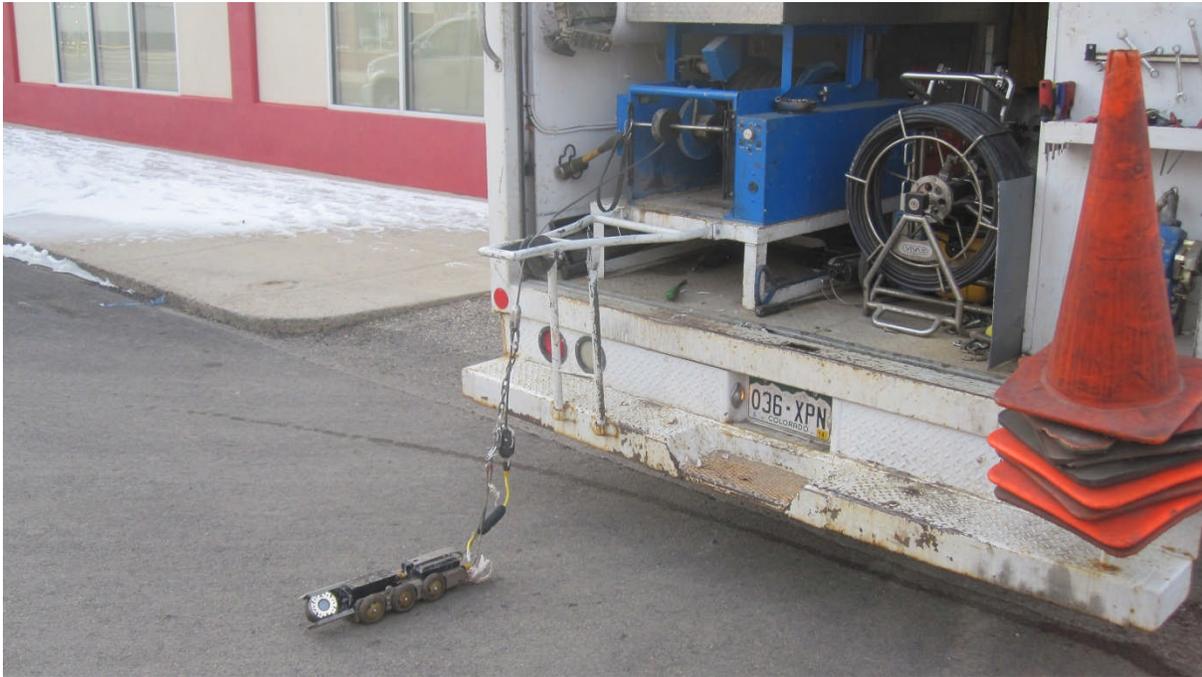
**Photograph No. 1**

View of wheel mounted sewer scope/camera and support vehicle.

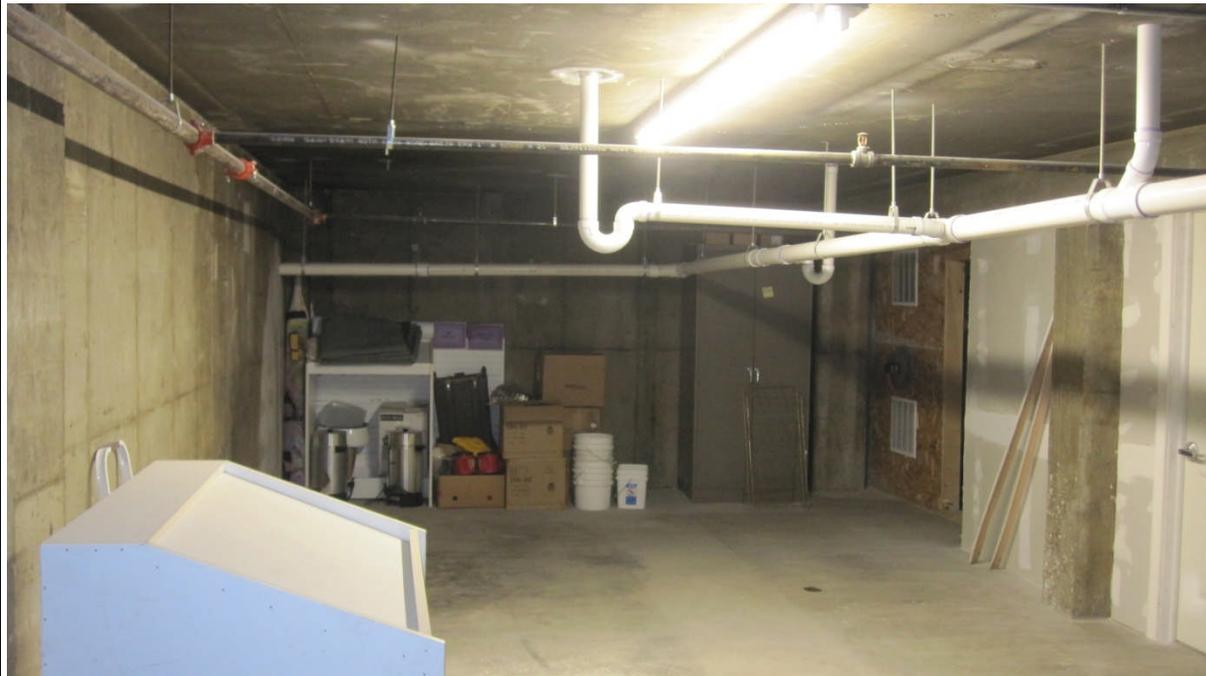
**Photograph No. 4**

View of sanitary sewer lines in the basement of the 12-24 Club building.

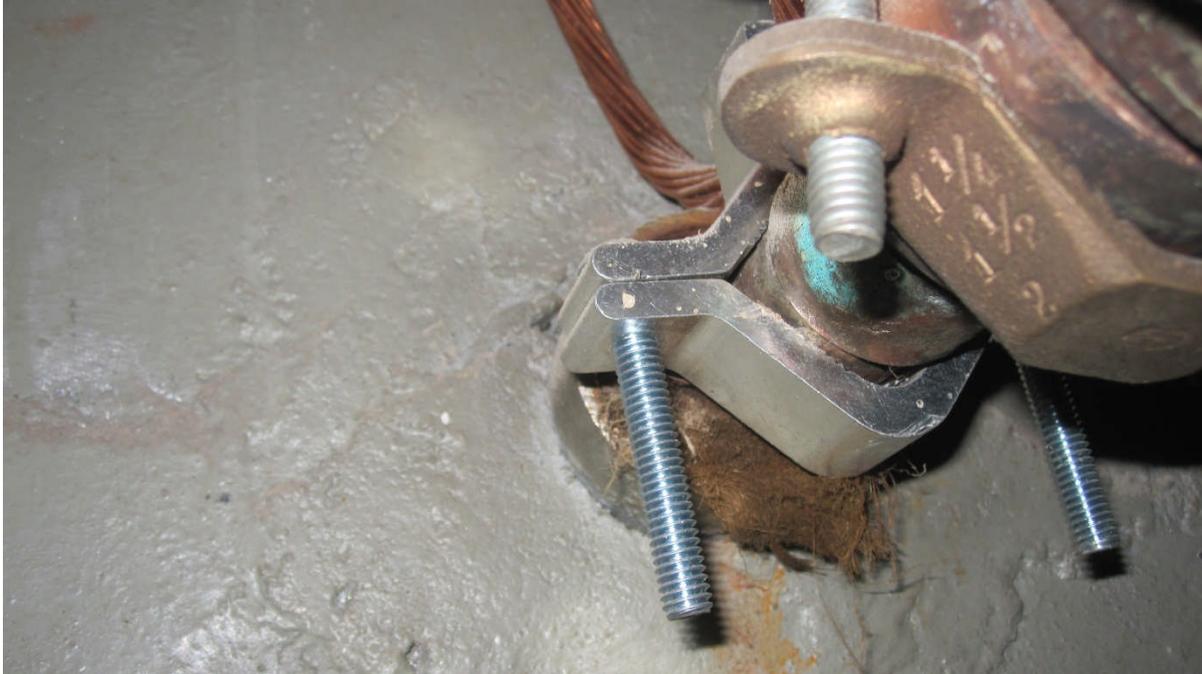
**Photograph No. 13**

View of gap and packing around the water line running through the south basement wall of the Salvation Army building.

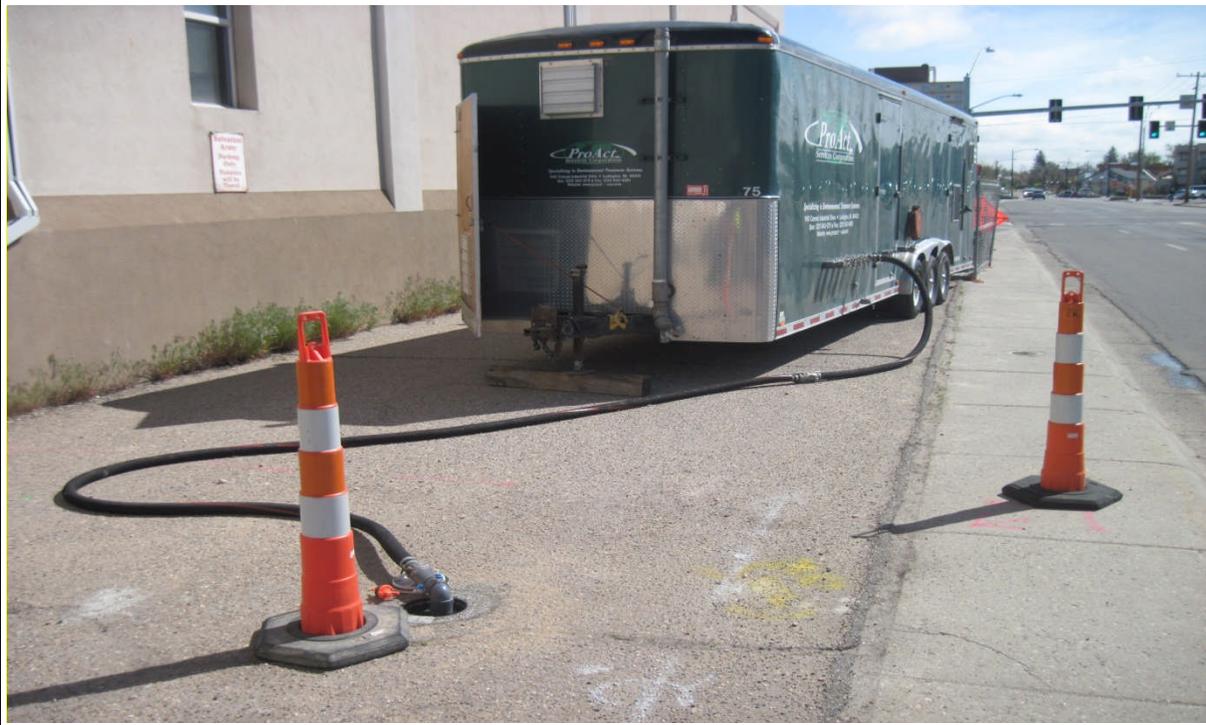
**Photograph No. 3**

View of SVE Pilot Study trailer connected to SVE-1S/1D.

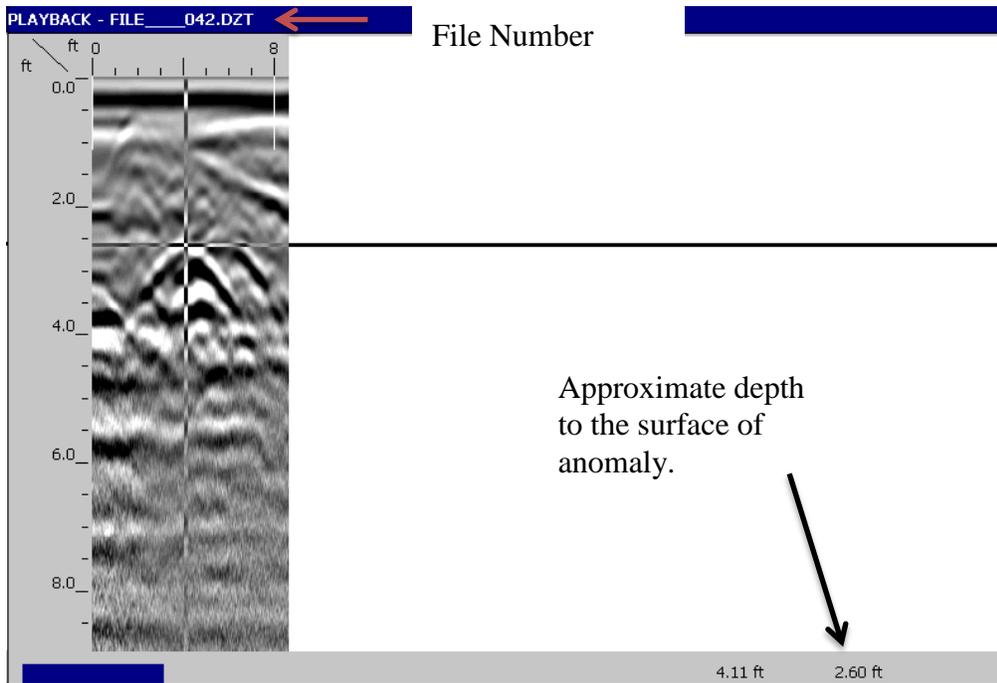
Photo of area running West to East just ahead of known UST's on North side of building on E Collins Dr. Anomaly is at approximately 2.6ft depth and is running in line with gas meter. File 042.

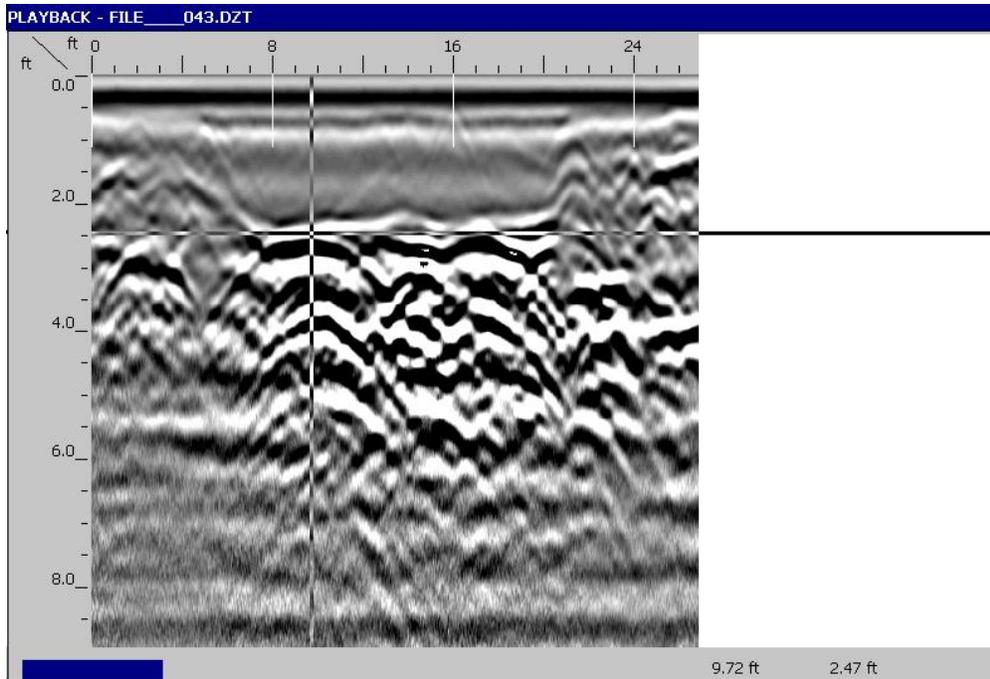
Data from area of known UST's running East to West on North side of building with approximate depth to surface of anomaly. File 043

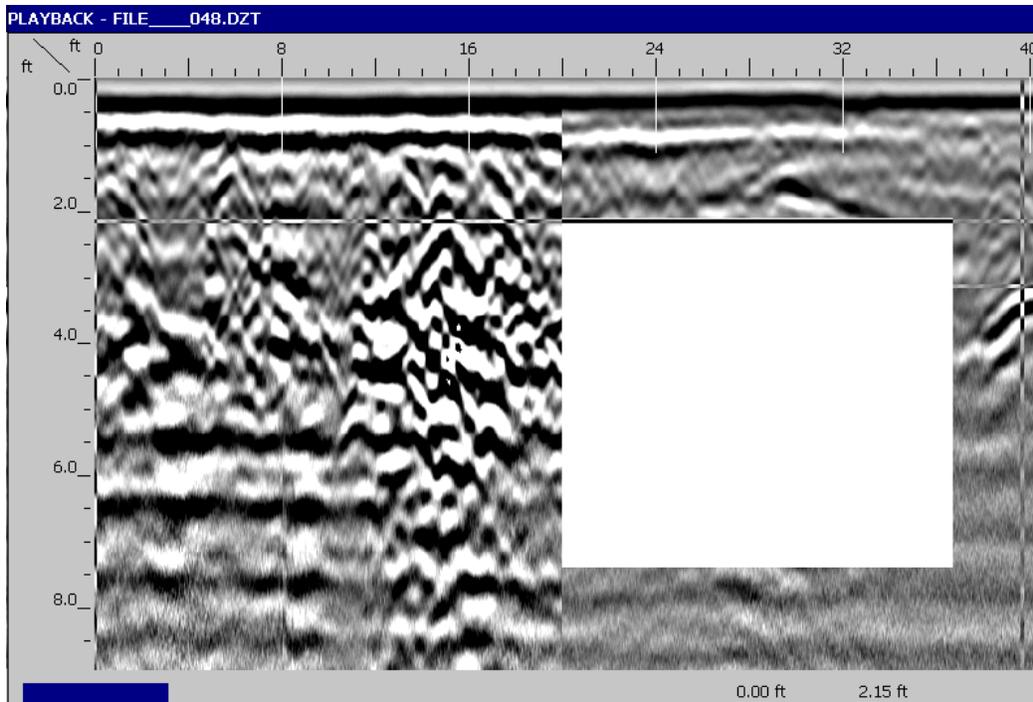
Data from first proposed area of sewer line running from cleaners on the south side of building running along 5<sup>th</sup> Street. GPR was unable to detect sewer line and Radio Detection was unable to set a tone on pipe. Pipe was field verified in basement of cleaners. Further investigation may be necessary. File 048

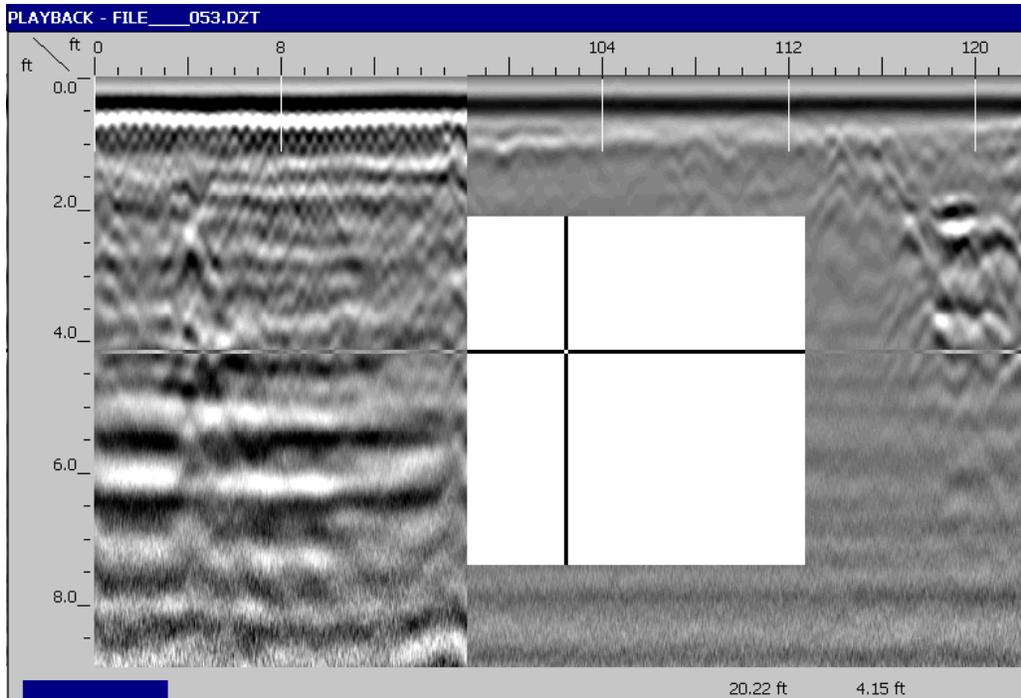
GPR Data from second proposed sewer line area on the north side of building running along 5<sup>th</sup> street. GPR was unable to locate sewer line running from building. File 053

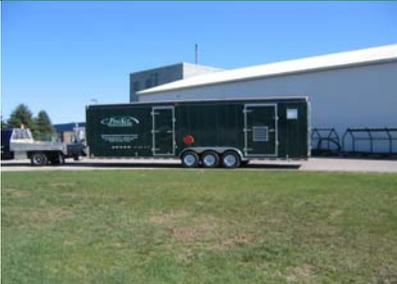
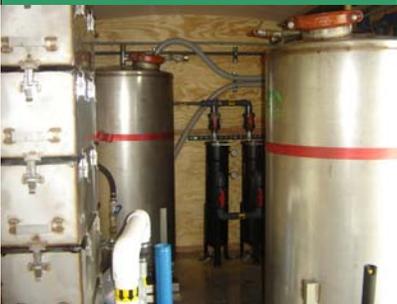
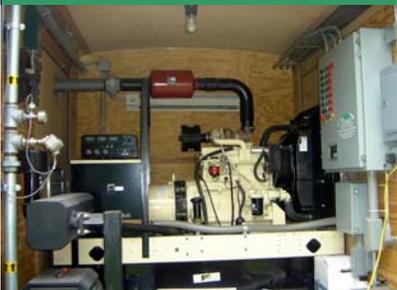
- General Specifications: 5 GPM water treatment  
300 ACFM @ 20" Hg Vacuum  
125 ACFM @ 25 PSI Sparge Pressure
- Trailer: 8ft wide x 32 ft long x 8 ft height  
21,000 pound triple axle trailer
